## Access Compliance Report Public Rights-of-Way (Curb Ramps)

Intersection ID: 10041482 Main Street: WESTPARK DR Cross Street: N/A								Lesstien	
Intersection ID: 10041482	D: 10041482 Main Street: WESTPARK_DR		Cross	Street:	N/A	Location:	NW		
ADA ID: 8AF09ABFACF7 Ramp Type: PerpDiag			Initial	Initial Pass/Fail: Fail Overall Compliance: No				o Severity Score:	21.25
Codes/Mitigation Info/Possible Solution				Field Measurements/Component Compliance					
	1/12	Possible Solutions:		Compliance Description		Data Compliance Description		Data

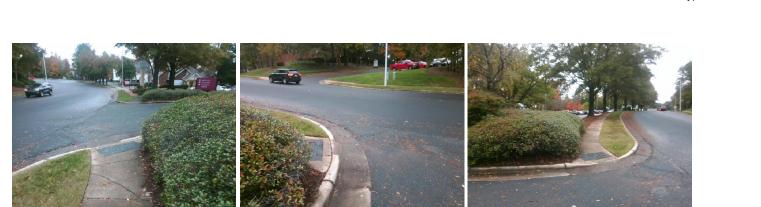
C. C. C. S. I.		Remove & Replace Curb Ramp	With	N/A	Ramp Length (in)	72.0	No	Ramp Slope (%)	11.7
		Two New Directional Ramps or Equivalent.		No	Ramp Width (in)	36.0	Yes	Ramp XSlope (%)	0.5
				N/A	Flare Type LT	N/A	N/A	Flare Type RT	N/A
