Access Compliance Report

Public Rights-of-Way

(Curb Ramps)

Intersection ID: 15725	Main Street: CLANTON_RD	Cross Street: S_TRYON_ST	Location: NE
ADA ID: 8AF343BC53DE	Ramp Type: Perp	Initial Pass/Fail: Fail	Overall Compliance: No
Severity Score: 46.25			
Codes/Mitigation Info/Possible Solution		Field Measurements/Component Compliance

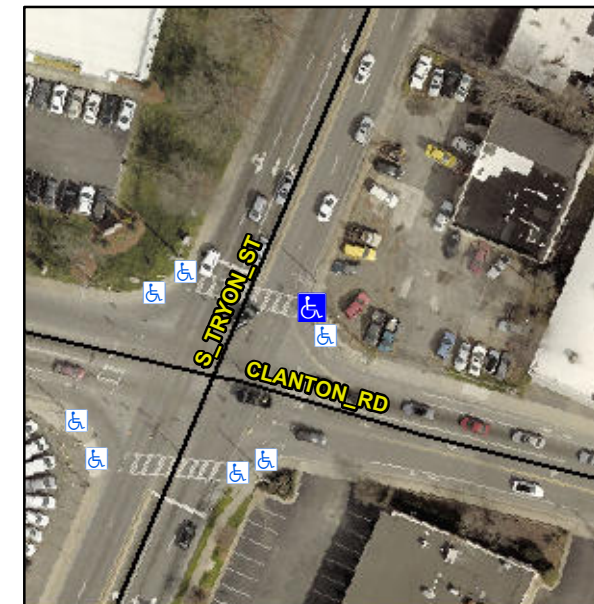
Not Found, R304.5.1, R304.2.2, R304.5.3

Compliance	Description	Data	Compliance	Description	Data
N/A	Ramp Length (in)	59.0	No	Ramp Slope (%)	8.8
No	Ramp Width (in)	47.5	No	Ramp XSlope (%)	7.9
N/A	Flare Type LT	N/A	N/A	Flare Type RT	N/A
N/A	Flare Slope LT (%)	N/A	N/A	Flare Slope RT (%)	N/A
N/A	Flare Traversable LT?	N/A	N/A	Flare Traversable RT?	N/A
N/A	Landing Length (in)	N/A	N/A	DWS Provided?	N/A
N/A	Landing Width (in)	N/A	N/A	DWS Contrast?	N/A
N/A	Landing Slope (%)	N/A	N/A	DWS Length (in)	N/A
N/A	Landing X Slope (%)	N/A	N/A	DWS Full Width?	N/A
N/A	Landing Curb? (Y/N)	N/A	N/A	DWS Offset (in)	N/A
N/A	Shared Landing?	N/A			
N/A	Gutter Ponding?	N/A	N/A	Gutter Slope (%)	N/A
N/A	Gutter Lip Ht (in)	N/A	N/A	Gutter X Slope (%)	N/A
N/A	Painted X Walk1?	Yes	N/A	Painted X Walk2?	N/A
	X Walk 1 Direction	To NW		X Walk 2 Direction	N/A
N/A	X Walk 1 Width (in)	112.0	N/A	X Walk 2 Width (in)	N/A
	X Walk 1 Slope (%)	1.6		X Walk 2 Slope (%)	N/A
	X Walk 1 X Slope (%)	5.1		X Walk 2 X Slope (%)	N/A

N/A	Ramp inside XWalk1?	Yes	N/A	Ramp inside XWalk2?	N/A
	Road Slope (%)	N/A	N/A	Clear Space?	N/A
	Road X Slope (%)	N/A	N/A	Clear Space to XWalk (in)	N/A
N/A	Any Obstructions?	N/A	N/A	Storm Grate/Utility Hazard?	N/A
	Obstruction Type			Storm Grate/Utility Type	
		N/A			N/A
			Yes	Surface Condition? (G/P)	Good

Possible Solutions:

Remove & Replace Entire Ramp.
