# Access Compliance Report

## Public Rights-of-Way

### (Curb Ramps)

Intersection ID: 12877	Main Street: E_5TH_ST	Cross Street: N_MYERS_ST	Location: S
ADA ID: 8B00F1B5AFA8	Ramp Type: PerpDiag	Initial Pass/Fail: Fail	Overall Compliance: No
		Severity Score: 25

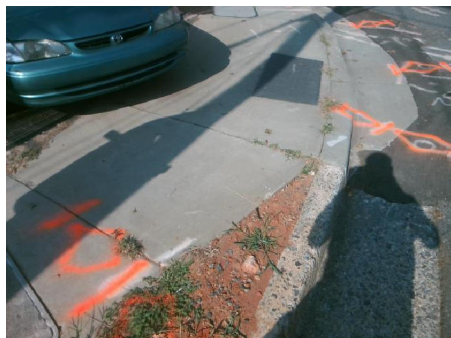
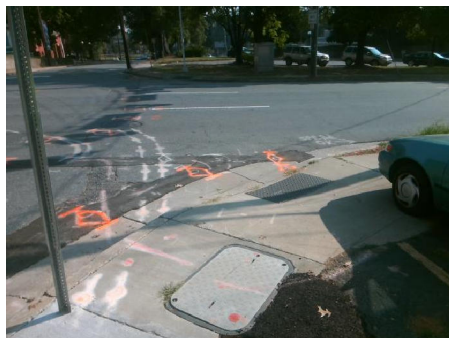
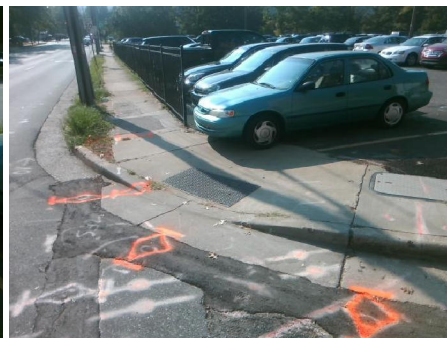
Compliance	Description	Data	Compliance	Description	Data
N/A	Ramp Length (in)	75.0	Yes	Ramp Slope (%)	6.7
Yes	Ramp Width (in)	49.0	No	Ramp XSlope (%)	8.4
N/A	Flare Type LT	N/A	N/A	Flare Type RT	N/A
N/A	Flare Slope LT (%)	N/A	N/A	Flare Slope RT (%)	N/A
N/A	Flare Traversable LT?	N/A	N/A	Flare Traversable RT?	N/A
N/A	Landing Length (in)	N/A	N/A	DWS Provided?	N/A
N/A	Landing Width (in)	N/A	N/A	DWS Contrast?	N/A
N/A	Landing Slope (%)	N/A	N/A	DWS Length (in)	N/A
N/A	Landing X Slope (%)	N/A	N/A	DWS Full Width?	N/A
N/A	Landing Curb? (Y/N)	N/A	N/A	DWS Offset (in)	N/A
N/A	Shared Landing?	N/A			
N/A	Gutter Ponding?	N/A	N/A	Gutter Slope (%)	N/A
N/A	Gutter Lip Ht (in)	N/A	N/A	Gutter X Slope (%)	N/A
N/A	Painted X Walk1?	No	N/A	Painted X Walk2?	No
	X Walk 1 Direction	To NE		X Walk 2 Direction	To NW
N/A	X Walk 1 Width (in)	N/A	N/A	X Walk 2 Width (in)	N/A
	X Walk 1 Slope (%)	5.9		X Walk 2 Slope (%)	8.8
	X Walk 1 X Slope (%)	10.0		X Walk 2 X Slope (%)	0.0

N/A	Ramp inside XWalk1?	N/A	N/A	Ramp inside XWalk2?	N/A
	Road Slope (%)	2.0	N/A	Clear Space?	N/A
	Road X Slope (%)	10.3	N/A	Clear Space to XWalk (in)	N/A
N/A	Any Obstructions?	N/A	N/A	Storm Grate/Utility Hazard?	N/A
	Obstruction Type			Storm Grate/Utility Type	
		N/A			N/A
			Yes	Surface Condition? (G/P)	Good

**Remove & Replace Curb Ramp With Two New Directional Ramps or Equivalent.**
