Access Compliance Report

Public Rights-of-Way

(Curb Ramps)

Intersection ID: 3126	Main Street: BROWNESTONE_VIEW_DR	Cross Street: GALENA_VIEW_DR	Location:	N
ADA ID: 8B030327A565	Ramp Type: Perp	Initial Pass/Fail: Fail	Overall Compliance: No	Severity Score: 12.5
Codes/Mitigation Info/Possible Solution		Field Measurements/Component Compliance

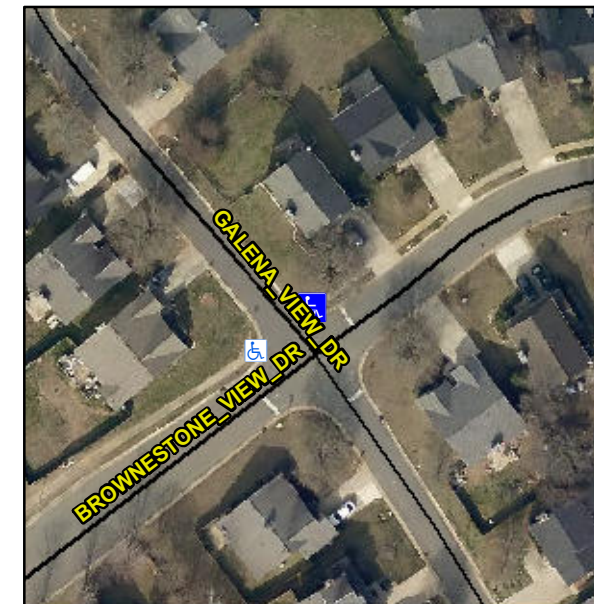
Compliance	Description	Data	Compliance	Description	Data
N/A	Ramp Length (in)	44.0	No	Ramp Slope (%)	10.1
Yes	Ramp Width (in)	48.0	Yes	Ramp XSlope (%)	1.0
N/A	Flare Type LT	N/A	N/A	Flare Type RT	N/A
N/A	Flare Slope LT (%)	N/A	N/A	Flare Slope RT (%)	N/A
N/A	Flare Traversable LT?	N/A	N/A	Flare Traversable RT?	N/A
N/A	Landing Length (in)	N/A	N/A	DWS Provided?	N/A
N/A	Landing Width (in)	N/A	N/A	DWS Contrast?	N/A
N/A	Landing Slope (%)	N/A	N/A	DWS Length (in)	N/A
N/A	Landing X Slope (%)	N/A	N/A	DWS Full Width?	N/A
N/A	Landing Curb? (Y/N)	N/A	N/A	DWS Offset (in)	N/A
N/A	Shared Landing?	N/A			
N/A	Gutter Ponding?	N/A	N/A	Gutter Slope (%)	N/A
N/A	Gutter Lip Ht (in)	N/A	N/A	Gutter X Slope (%)	N/A
N/A	Painted X Walk1?	No	N/A	Painted X Walk2?	N/A
	X Walk 1 Direction	To SW		X Walk 2 Direction	N/A
N/A	X Walk 1 Width (in)	N/A	N/A	X Walk 2 Width (in)	N/A
	X Walk 1 Slope (%)	3.5		X Walk 2 Slope (%)	N/A
	X Walk 1 X Slope (%)	4.7		X Walk 2 X Slope (%)	N/A

N/A	Ramp inside XWalk1?	N/A	N/A	Ramp inside XWalk2?	N/A
	Road Slope (%)	N/A	N/A	Clear Space?	N/A
	Road X Slope (%)	N/A	N/A	Clear Space to XWalk (in)	N/A
N/A	Any Obstructions?	N/A	N/A	Storm Grate/Utility Hazard?	N/A
	Obstruction Type			Storm Grate/Utility Type	
		N/A			N/A
			Yes	Surface Condition? (G/P)	Good

Possible Solutions:

Remove & Replace Entire Ramp.

Not Found, R304.2.2
