Access Compliance Report

Public Rights-of-Way

(Curb Ramps)

Intersection ID: 28625	Main Street: GREYBRIAR_FOREST_LN	Cross Street: PEDLAR_MILLS_RD	Location: NW
ADA ID: 8B07421C6B72	Ramp Type: BlendTrans1	Initial Pass/Fail: Fail	Overall Compliance: No
Codes/Mitigation Info/Possible Solution			Severity Score: 35
			Field Measurements/Component Compliance

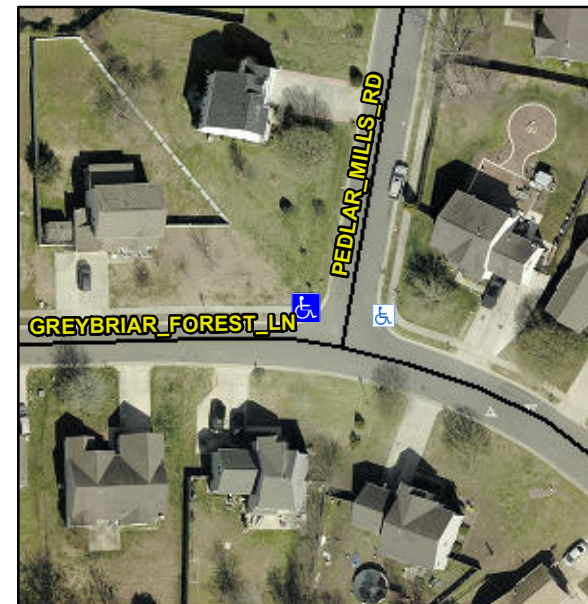
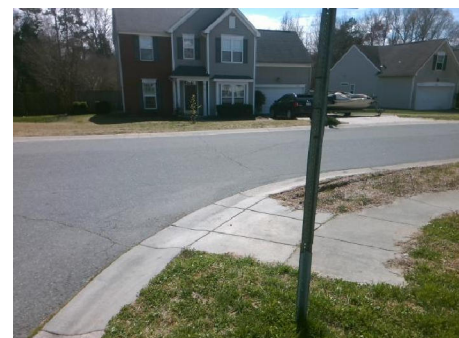
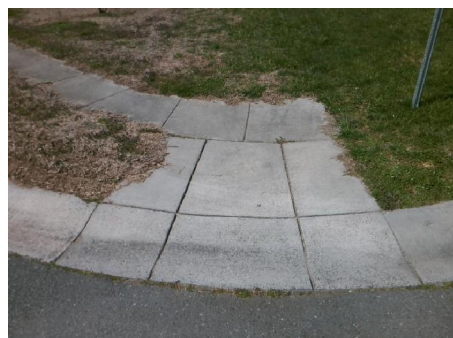
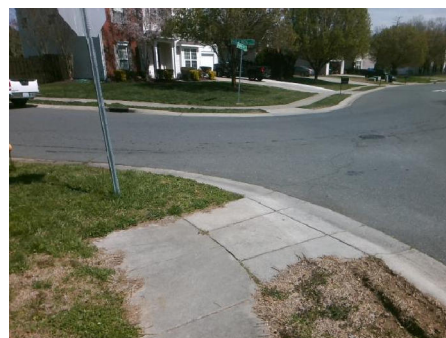
Not Found, R304.5.1

Compliance	Description	Data	Compliance	Description	Data
N/A	Ramp Length (in)	46.5	Yes	BlendTrans Slope (%)	4.2
No	Ramp Width (in)	31.0	Yes	BlendTrans XSlope (%)	1.4
N/A	Flare Type LT	N/A	N/A	Flare Type RT	N/A
N/A	Flare Slope LT (%)	N/A	N/A	Flare Slope RT (%)	N/A
N/A	Flare Traversable LT?	N/A	N/A	Flare Traversable RT?	N/A
N/A	Landing Length (in)	N/A	N/A	DWS Provided?	N/A
N/A	Landing Width (in)	N/A	N/A	DWS Contrast?	N/A
N/A	Landing Slope (%)	N/A	N/A	DWS Length (in)	N/A
N/A	Landing X Slope (%)	N/A	N/A	DWS Full Width?	N/A
N/A	Landing Curb? (Y/N)	N/A	N/A	DWS Offset (in)	N/A
N/A	Shared Landing?	N/A			
N/A	Gutter Ponding?	N/A	N/A	Gutter Slope (%)	N/A
N/A	Gutter Lip Ht (in)	N/A	N/A	Gutter X Slope (%)	N/A
N/A	Painted X Walk1?	No	N/A	Painted X Walk2?	No
	X Walk 1 Direction	To S		X Walk 2 Direction	To E
	X Walk 1 Width (in)	N/A		X Walk 2 Width (in)	N/A
	X Walk 1 Slope (%)	1.5		X Walk 2 Slope (%)	2.1
	X Walk 1 X Slope (%)	0.0		X Walk 2 X Slope (%)	0.0

N/A	Ramp inside XWalk1?	N/A	N/A	Ramp inside XWalk2?	N/A
	Road Slope (%)	1.5		Clear Space?	N/A
	Road X Slope (%)	1.2	N/A	Clear Space to XWalk (in)	N/A
N/A	Any Obstructions?	N/A	N/A	Storm Grate/Utility Hazard?	N/A
	Obstruction Type			Storm Grate/Utility Type	
		N/A			N/A
			Yes	Surface Condition? (G/P)	Good
			No	Curb Slope (%)	7.3

Remove & Replace Curb Ramp With Two New Directional Ramps or Equivalent.
