Access Compliance Report

Public Rights-of-Way

(Curb Ramps)

Intersection ID: 30018	Main Street: W_MALLARD_CREEK_CHURCH_RD	Cross Street: BERKELEY_PLACE_DR	Location: NW
ADA ID: 8B084FFC8394	Ramp Type: Perp	Initial Pass/Fail: Fail	Overall Compliance: No
Severity Score: 26.25			
Codes/Mitigation Info/Possible Solution		Field Measurements/Component Compliance

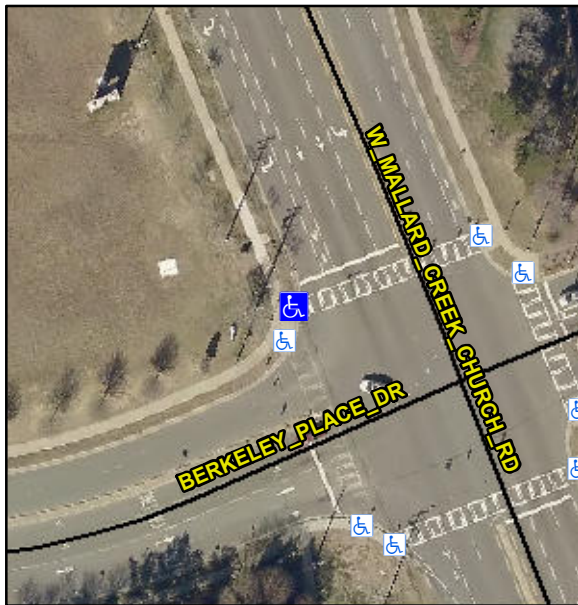
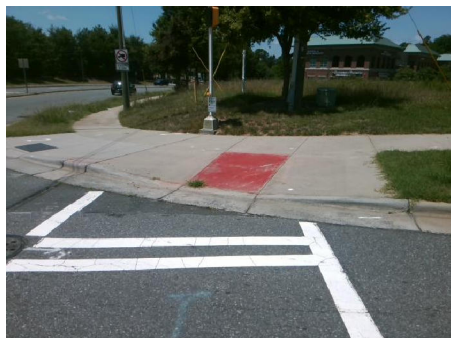
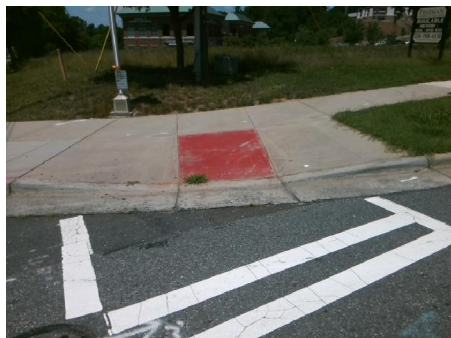
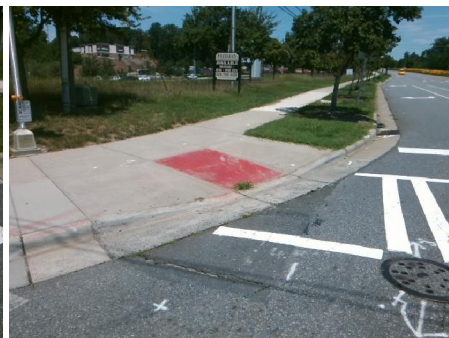
Compliance	Description	Data	Compliance	Description	Data
N/A	Ramp Length (in)	79.0	No	Ramp Slope (%)	20.0
Yes	Ramp Width (in)	48.0	Yes	Ramp XSlope (%)	3.7
N/A	Flare Type LT	N/A	N/A	Flare Type RT	N/A
N/A	Flare Slope LT (%)	N/A	N/A	Flare Slope RT (%)	N/A
N/A	Flare Traversable LT?	N/A	N/A	Flare Traversable RT?	N/A
N/A	Landing Length (in)	N/A	N/A	DWS Provided?	N/A
N/A	Landing Width (in)	N/A	N/A	DWS Contrast?	N/A
N/A	Landing Slope (%)	N/A	N/A	DWS Length (in)	N/A
N/A	Landing X Slope (%)	N/A	N/A	DWS Full Width?	N/A
N/A	Landing Curb? (Y/N)	N/A	N/A	DWS Offset (in)	N/A
N/A	Shared Landing?	N/A			
N/A	Gutter Ponding?	N/A	N/A	Gutter Slope (%)	N/A
N/A	Gutter Lip Ht (in)	N/A	N/A	Gutter X Slope (%)	N/A
N/A	Painted X Walk1?	Yes	N/A	Painted X Walk2?	N/A
	X Walk 1 Direction	To E		X Walk 2 Direction	N/A
N/A	X Walk 1 Width (in)	105.0	N/A	X Walk 2 Width (in)	N/A
	X Walk 1 Slope (%)	1.5		X Walk 2 Slope (%)	N/A
	X Walk 1 X Slope (%)	3.8		X Walk 2 X Slope (%)	N/A

N/A	Ramp inside XWalk1?	Yes	N/A	Ramp inside XWalk2?	N/A
	Road Slope (%)	N/A	N/A	Clear Space?	N/A
	Road X Slope (%)	N/A	N/A	Clear Space to XWalk (in)	N/A
N/A	Any Obstructions?	N/A	N/A	Storm Grate/Utility Hazard?	N/A
	Obstruction Type			Storm Grate/Utility Type	
		N/A			N/A
		Yes		Surface Condition? (G/P)	Good

Remove & Replace Entire Ramp.
