Access Compliance Report

Public Rights-of-Way

(Curb Ramps)

Intersection ID: 4866	Main Street: E MALLARD CREEK CHURCH RD	Cross Street: N TRYON ST	Location: S
ADA ID: 8B155E3FD88B	Ramp Type: Perp	Initial Pass/Fail: Fail	Overall Compliance: No
Severity Score: 21.25			
Codes/Mitigation Info/Possible Solution		Field Measurements/Component Compliance

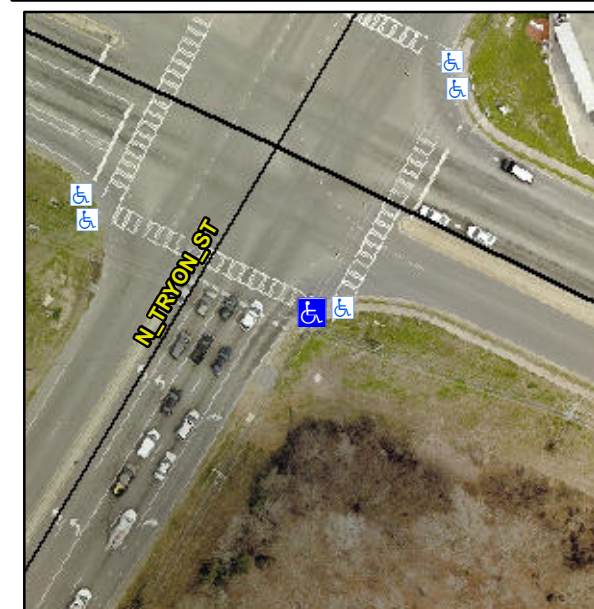
R304.5.1, R304.5.3

Compliance	Description	Data	Compliance	Description	Data
N/A	Ramp Length (in)	60.0	Yes	Ramp Slope (%)	7.1
No	Ramp Width (in)	41.0	No	Ramp XSlope (%)	5.1
N/A	Flare Type LT	N/A	N/A	Flare Type RT	N/A
N/A	Flare Slope LT (%)	N/A	N/A	Flare Slope RT (%)	N/A
N/A	Flare Traversable LT?	N/A	N/A	Flare Traversable RT?	N/A
N/A	Landing Length (in)	N/A	N/A	DWS Provided?	N/A
N/A	Landing Width (in)	N/A	N/A	DWS Contrast?	N/A
N/A	Landing Slope (%)	N/A	N/A	DWS Length (in)	N/A
N/A	Landing X Slope (%)	N/A	N/A	DWS Full Width?	N/A
N/A	Landing Curb? (Y/N)	N/A	N/A	DWS Offset (in)	N/A
N/A	Shared Landing?	N/A			
N/A	Gutter Ponding?	N/A	N/A	Gutter Slope (%)	N/A
N/A	Gutter Lip Ht (in)	N/A	N/A	Gutter X Slope (%)	N/A
N/A	Painted X Walk1?	Yes	N/A	Painted X Walk2?	N/A
	X Walk 1 Direction	To NW		X Walk 2 Direction	N/A
N/A	X Walk 1 Width (in)	97.0	N/A	X Walk 2 Width (in)	N/A
	X Walk 1 Slope (%)	1.2		X Walk 2 Slope (%)	N/A
	X Walk 1 X Slope (%)	2.5		X Walk 2 X Slope (%)	N/A

N/A	Ramp inside XWalk1?	Yes	N/A	Ramp inside XWalk2?	N/A
	Road Slope (%)	N/A	N/A	Clear Space?	N/A
	Road X Slope (%)	N/A	N/A	Clear Space to XWalk (in)	N/A
N/A	Any Obstructions?	N/A	N/A	Storm Grate/Utility Hazard?	N/A
	Obstruction Type			Storm Grate/Utility Type	
		N/A			N/A
		Yes		Surface Condition? (G/P)	Good

Remove & Replace Entire Ramp.

Total Cost: \$ 1850.00
