Access Compliance Report

Public Rights-of-Way

(Curb Ramps)

| Intersection ID: N/A | Main Street: ARROWOOD_RD | Cross Street: ALTACREST_PL | Location: NW |

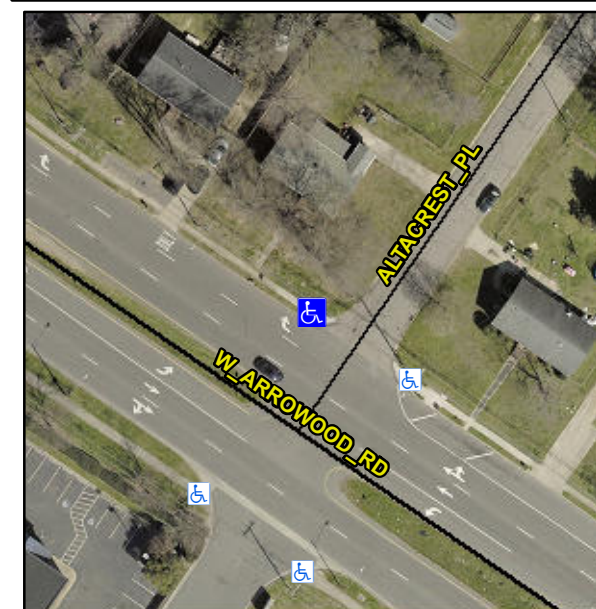
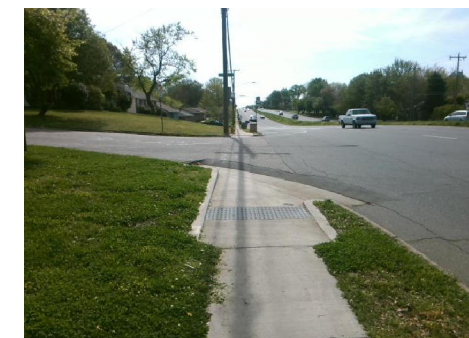
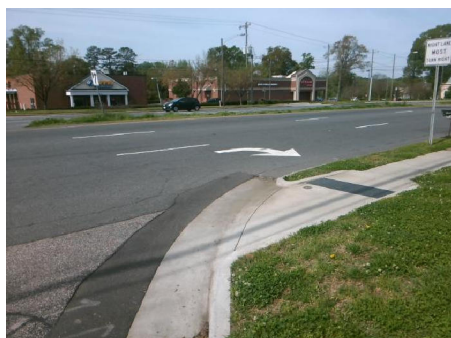
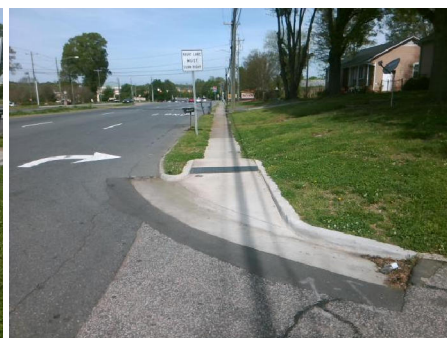
| ADA ID: 8B16604E78B5 | Ramp Type: Directional1 | Initial Pass/Fail: Fail | Overall Compliance: No |

| Severity Score: 12.5 | | | |

R304.5.3

| Compliance | Description | Data | Compliance | Description | Data |
|---|---|---|---|---|---|
| No | Ramp XSlope (%) | 5.8 | | | |

Remove & Replace Entire Ramp.
