Access Compliance Report

Public Rights-of-Way

(Curb Ramps)

Intersection ID: 42643	Main Street: E_3RD_ST	Cross Street: E_JOHN_BELK_RA	Location: NW
ADA ID: 8B1748DB2E58	Ramp Type: Directional1	Initial Pass/Fail: Fail	Overall Compliance: No
		Severity Score: 1.25

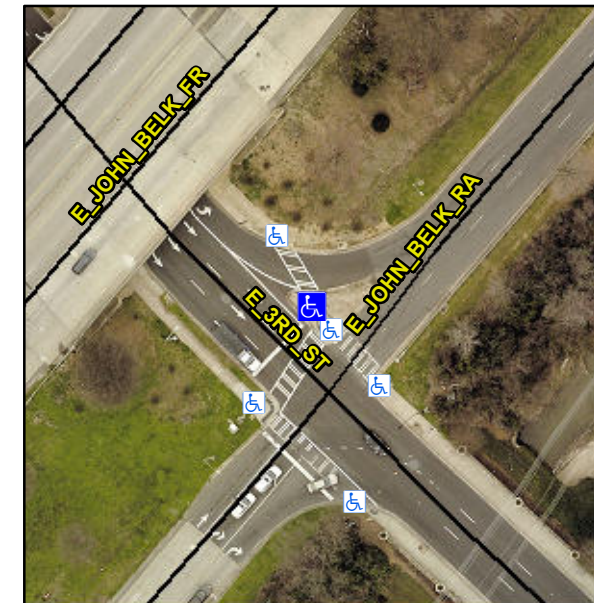
LOCATED ON ISLAND

R304.5.3

Compliance	Description	Data	Compliance	Description	Data
N/A	Ramp Length (in)	90.0	N/A	Grade Break?	N/A
Yes	Ramp Width (in)	72.0	N/A	Grade Break Slope (%)	0.0
Yes	Ramp Slope (%)	5.7	N/A	Grade Break XSlope (%)	0.0
No	Ramp XSlope (%)	2.9			
N/A	Flare Type LT	N/A	N/A	Flare Type RT	N/A
N/A	Flare Slope LT (%)	N/A	N/A	Flare Slope RT (%)	0.0
N/A	Flare Traversable LT?	N/A	N/A	Flare Traversable RT?	N/A
N/A	Landing Length (in)	0.0	N/A	DWS Provided?	N/A
N/A	Landing Width (in)	0.0	N/A	DWS Contrast?	N/A
N/A	Landing Slope (%)	0.0	N/A	DWS Length (in)	N/A
N/A	Landing X Slope (%)	0.0	N/A	DWS Full Width?	N/A
N/A	Landing Curb? (Y/N)	N/A	N/A	DWS Offset LT (in)	N/A
N/A	Shared Landing?	N/A	N/A	DWS Offset RT (in)	N/A
N/A	Gutter Ponding?	0.0	N/A	Gutter Slope (%)	N/A
N/A	Gutter Lip Ht (in)	0.0	N/A	Gutter X Slope (%)	N/A
N/A	Painted X Walk1?	Yes		Road Slope (%)	1.9
	X Walk 1 Direction	To NW		Road X Slope (%)	2.9
	X Walk 1 Width (in)	108.0		Clear Space?	N/A

X Walk 1 Slope (%)	1.9	N/A	Clear Space to XWalk (in)	N/A
	X Walk 1 X Slope (%)	2.9	N/A	Storm Grate/Utility Hazard?	N/A
N/A	Ramp inside XWalk1?	Yes		Storm Grate/Utility Type	
N/A	Any Obstructions?	N/A			N/A
	Obstruction Type		Yes	Surface Condition? (G/P)	Good
			N/A	Curb Slope (%)	12.8

Remove & Replace Entire Ramp.
