Access Compliance Report

Public Rights-of-Way

(Curb Ramps)

| Intersection ID: 10033470 | Main Street: OLD_PINEVILLE_RD | Cross Street: N/A | Location: SW |

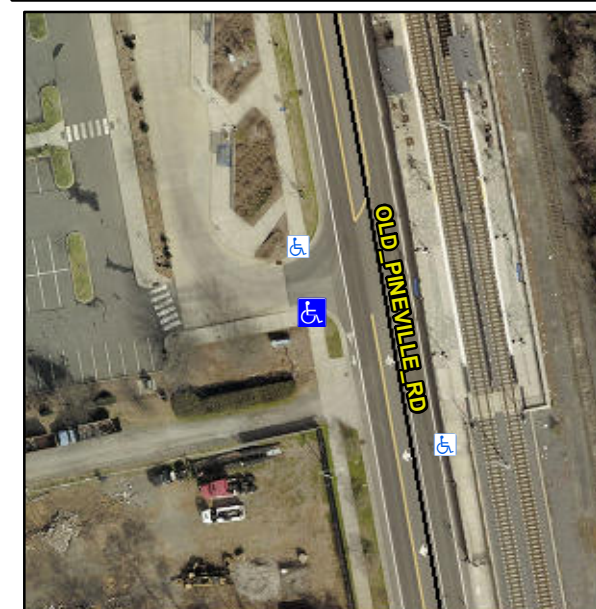
**R304.5.3, R304.2.3, R305.1.4, R305.2,
R304.5.4**

| Compliance | Description | Data | Compliance | Description | Data |
|---|---|---|---|---|---|
| No | Landing X Slope (%) | 2.6 | No | DWS Full Width? | No |
| N/A | Landing Curb? (Y/N) | No | No | DWS Offset LT (in) | 3.0 |
| Yes | Gutter Ponding? | No | No | Gutter Slope (%) | 6.5 |
| Yes | Gutter Lip Ht (in) | 0.0 | No | Gutter X Slope (%) | 2.2 |

Possible Solutions:

**Remove & Replace Entire Ramp.
Remove & Replace Gutter.**
