# Access Compliance Report

## Public Rights-of-Way

### (Curb Ramps)

Intersection ID: 6170	Main Street: OAKBLUFF_CR	Cross Street: TIMBERBLUFF_DR	Location: SW
ADA ID: 8B1FB4A6CD94	Ramp Type: Directional1	Initial Pass/Fail: Pass	Overall Compliance: No
		Severity Score: 0

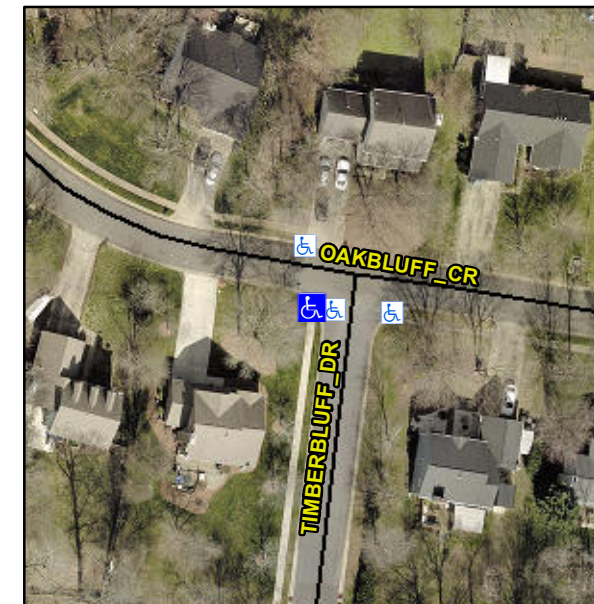
Compliance	Description	Data	Compliance	Description	Data
N/A	Ramp Length (in)	44.5	N/A	Grade Break?	N/A
Yes	Ramp Width (in)	48.0	N/A	Grade Break Slope (%)	0.0
Yes	Ramp Slope (%)	1.3	N/A	Grade Break XSlope (%)	0.0
Yes	Ramp XSlope (%)	1.0			
N/A	Flare Type LT	N/A	N/A	Flare Type RT	N/A
N/A	Flare Slope LT (%)	N/A	N/A	Flare Slope RT (%)	N/A
N/A	Flare Traversable LT?	N/A	N/A	Flare Traversable RT?	N/A
Yes	Landing Length (in)	59.5	Yes	DWS Provided?	Yes
Yes	Landing Width (in)	48.0	Yes	DWS Contrast?	Yes
Yes	Landing Slope (%)	0.6	Yes	DWS Length (in)	25.5
Yes	Landing X Slope (%)	1.4	Yes	DWS Full Width?	Yes
N/A	Landing Curb? (Y/N)	No	No	DWS Offset LT (in)	5.0
N/A	Shared Landing?	No	Yes	DWS Offset RT (in)	53.0
Yes	Gutter Ponding?	No	Yes	Gutter Slope (%)	1.0
Yes	Gutter Lip Ht (in)	0.0	Yes	Gutter X Slope (%)	1.1
N/A	Painted X Walk1?	No		Road Slope (%)	2.0
	X Walk 1 Direction	To N		Road X Slope (%)	0.7
	X Walk 1 Width (in)	N/A		Clear Space?	Yes

X Walk 1 Slope (%)	2.0	N/A	Clear Space to XWalk (in)	N/A
	X Walk 1 X Slope (%)	0.7	Yes	Storm Grate/Utility Hazard?	No
N/A	Ramp inside XWalk1?	N/A		Storm Grate/Utility Type	
Yes	Any Obstructions?	No			N/A
	Obstruction Type		Yes	Surface Condition? (G/P)	Good
			N/A	Curb Slope (%)	4.1

Possible Solutions:

**Remove & Replace Detectable Warning System.**

**R305.2**

\$ 800.00
