# Access Compliance Report

## Public Rights-of-Way

### (Curb Ramps)

Intersection ID: 13098	Main Street: S_CHURCH_ST	Cross Street: LINCOLN_ST	Location: W
ADA ID: 8B24818D2018	Ramp Type: PerpDiag	Initial Pass/Fail: Fail	Overall Compliance: No
		Severity Score: 8.75	
Codes/Mitigation Info/Possible Solution		Field Measurements/Component Compliance

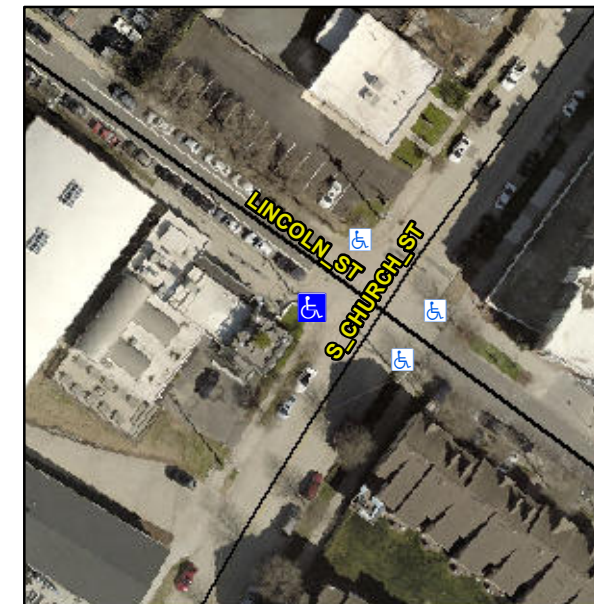
**Not Found, R304.5.1**

Compliance	Description	Data	Compliance	Description	Data
N/A	Ramp Length (in)	82.0	Yes	Ramp Slope (%)	7.5
No	Ramp Width (in)	36.0	Yes	Ramp XSlope (%)	1.2
N/A	Flare Type LT	N/A	N/A	Flare Type RT	N/A
N/A	Flare Slope LT (%)	N/A	N/A	Flare Slope RT (%)	N/A
N/A	Flare Traversable LT?	N/A	N/A	Flare Traversable RT?	N/A
N/A	Landing Length (in)	N/A	N/A	DWS Provided?	N/A
N/A	Landing Width (in)	N/A	N/A	DWS Contrast?	N/A
N/A	Landing Slope (%)	N/A	N/A	DWS Length (in)	N/A
N/A	Landing X Slope (%)	N/A	N/A	DWS Full Width?	N/A
N/A	Landing Curb? (Y/N)	N/A	N/A	DWS Offset (in)	N/A
N/A	Shared Landing?	N/A			
N/A	Gutter Ponding?	N/A	N/A	Gutter Slope (%)	N/A
N/A	Gutter Lip Ht (in)	N/A	N/A	Gutter X Slope (%)	N/A
N/A	Painted X Walk1?	No	N/A	Painted X Walk2?	No
	X Walk 1 Direction	To SE		X Walk 2 Direction	To NE
N/A	X Walk 1 Width (in)	N/A	N/A	X Walk 2 Width (in)	N/A
	X Walk 1 Slope (%)	1.8		X Walk 2 Slope (%)	1.2
	X Walk 1 X Slope (%)	1.9		X Walk 2 X Slope (%)	1.4

N/A	Ramp inside XWalk1?	N/A	N/A	Ramp inside XWalk2?	N/A
	Road Slope (%)	0.5	N/A	Clear Space?	N/A
	Road X Slope (%)	1.9	N/A	Clear Space to XWalk (in)	N/A
N/A	Any Obstructions?	N/A	N/A	Storm Grate/Utility Hazard?	N/A
	Obstruction Type			Storm Grate/Utility Type	
		N/A			N/A
			Yes	Surface Condition? (G/P)	Good

**Remove & Replace Curb Ramp With Two New Directional Ramps or Equivalent.**
