Access Compliance Report

Public Rights-of-Way

(Curb Ramps)

Intersection ID: 27418	Main Street: BALLANTYNE_COMMONS_PY	Cross Street: BALLANTYNE_TRACE_CT	Location: SW
ADA ID: 8B29D5AEFF21	Ramp Type: BlendTrans2	Initial Pass/Fail: Fail	Overall Compliance: No
Severity Score: 12.5			
Codes/Mitigation Info/Possible Solution		Field Measurements/Component Compliance

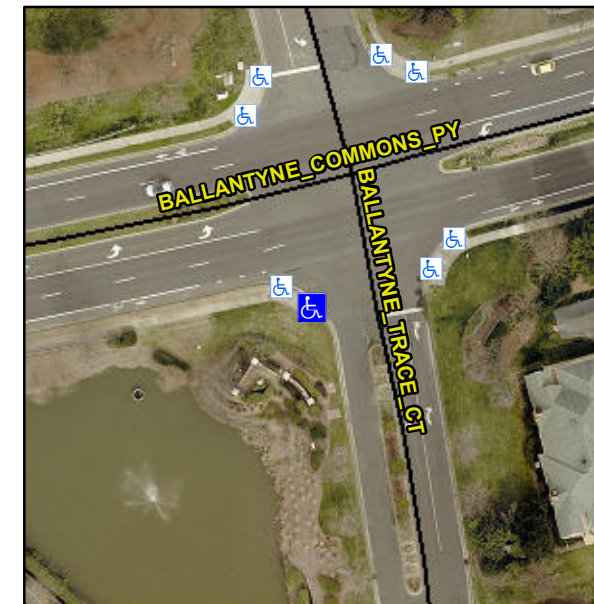
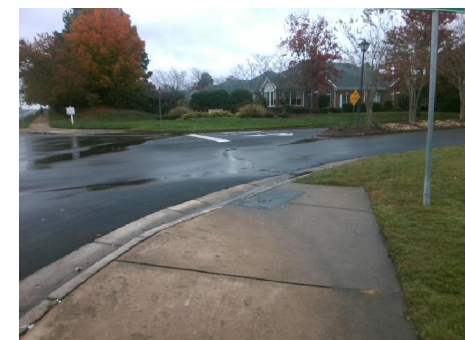
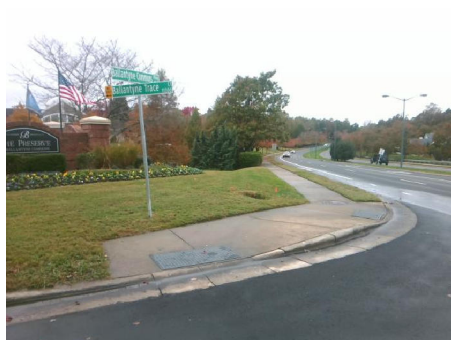
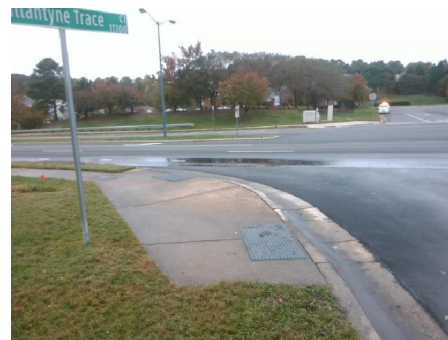
Not Found, R304.5.3

Compliance	Description	Data	Compliance	Description	Data
N/A	Ramp Length (in)	80.0	Yes	BlendTrans Slope (%)	3.5
Yes	Ramp Width (in)	59.0	No	BlendTrans XSlope (%)	5.6
N/A	Flare Type LT	N/A	N/A	Flare Type RT	N/A
N/A	Flare Slope LT (%)	N/A	N/A	Flare Slope RT (%)	N/A
N/A	Flare Traversable LT?	N/A	N/A	Flare Traversable RT?	N/A
N/A	Landing Length (in)	N/A	N/A	DWS Provided?	N/A
N/A	Landing Width (in)	N/A	N/A	DWS Contrast?	N/A
N/A	Landing Slope (%)	N/A	N/A	DWS Length (in)	N/A
N/A	Landing X Slope (%)	N/A	N/A	DWS Full Width?	N/A
N/A	Landing Curb? (Y/N)	N/A	N/A	DWS Offset (in)	N/A
N/A	Shared Landing?	N/A			
N/A	Gutter Ponding?	N/A	N/A	Gutter Slope (%)	N/A
N/A	Gutter Lip Ht (in)	N/A	N/A	Gutter X Slope (%)	N/A
N/A	Painted X Walk1?	No	N/A	Painted X Walk2?	N/A
	X Walk 1 Direction	To E		X Walk 2 Direction	N/A
	X Walk 1 Width (in)	N/A		X Walk 2 Width (in)	N/A
	X Walk 1 Slope (%)	0.8		X Walk 2 Slope (%)	N/A
	X Walk 1 X Slope (%)	2.5		X Walk 2 X Slope (%)	N/A

N/A	Ramp inside XWalk1?	N/A	N/A	Ramp inside XWalk2?	N/A
	Road Slope (%)	2.5		Clear Space?	N/A
	Road X Slope (%)	0.8	N/A	Clear Space to XWalk (in)	N/A
N/A	Any Obstructions?	N/A	N/A	Storm Grate/Utility Hazard?	N/A
	Obstruction Type			Storm Grate/Utility Type	
		N/A			N/A
		Yes		Surface Condition? (G/P)	Good
		No		Curb Slope (%)	5.1

Possible Solutions:

Remove & Replace Curb Ramp With Two New Directional Ramps or Equivalent.
