Access Compliance Report Public Rights-of-Way (Curb Ramps)

Intersection ID: 19908Main Street:BROWN-GRIER_RDCross Street:GALLANT_LNLocation:NWADA ID: 8B3339D0CAD0Ramp Type:Directional1Initial Pass/Fail:FailOverall Compliance:NoSeverity Score:12.5

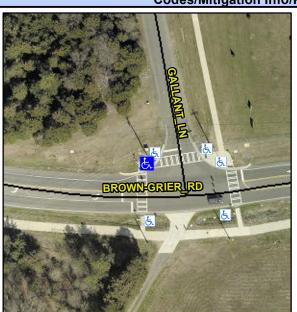
Field Measurements/Component Compliance									
	Compli	ance Description	Data	Compli	ance	Description	Data		
	N/A	Ramp Length (in)	33.0	N/A	Grad	e Break?	N/A		
	Yes	Ramp Width (in)	71.5	N/A	Grad	e Break Slope (%)	0.0		
	Yes	Ramp Slope (%)	1.4	N/A	Grad	e Break XSlope (%)	0.0		
	No	Ramp XSlope (%)	5.2						
	N/A	Flare Type LT	N/A	N/A	Flare	Type RT	N/A		
	N/A	Flare Slope LT (%)	N/A	N/A	Flare	Slope RT (%)	0.0		
	N/A	Flare Traversable LT?	N/A	N/A	Flare	Traversable RT?	N/A		
	N/A	Landing Length (in)	0.0	N/A	DWS	Provided?	N/A		
	N/A	Landing Width (in)	0.0	N/A	DWS	Contrast?	N/A		
	N/A	Landing Slope (%)	0.0	N/A	DWS	Length (in)	N/A		
	N/A	Landing X Slope (%)	0.0	N/A	DWS	Full Width?	N/A		
	N/A	Landing Curb? (Y/N)	N/A	N/A	DWS	Offset LT (in)	N/A		
	N/A	Shared Landing?	N/A	N/A	DWS	Offset RT (in)	N/A		
	N/A	Gutter Ponding?	0.0	N/A	Gutte	er Slope (%)	N/A		
	N/A	Gutter Lip Ht (in)	0.0	N/A	Gutte	er X Slope (%)	N/A		
	N/A	Painted X Walk1?	Yes		Road	Slope (%)	4.9

X Walk 1 Direction	To S		Road	X Slope (%)	5.3		
		X Walk 1 Width (in)	110.0		Clear	Space?	N/A		
		X Walk 1 Slope (%)	4.9	N/A	Clear	Space to XWalk (in)	N/A		
		X Walk 1 X Slope (%)	5.3	N/A	Storn	n Grate/Utility Hazard?	N/A		
	N/A	Ramp inside XWalk1?	Yes		Storn	n Grate/Utility Type			
	N/A	Any Obstructions?	N/A				N/A		
		Obstruction Type		Yes	Surfa	ice Condition? (G/P)	Good		
			N/A	N/A	Curb	Slope (%)	4.8

Remove & Replace Entire Ramp.

PROW/ADA:
R304.5.3
