# Access Compliance Report

## Public Rights-of-Way

### (Curb Ramps)

Intersection ID: N/A	Main Street: ARROW PINE DR	Cross Street: N/A	Location: S
ADA ID: 8B3673AD8D6C	Ramp Type: Perp	Initial Pass/Fail: Pass	Overall Compliance: No
		Severity Score: 15

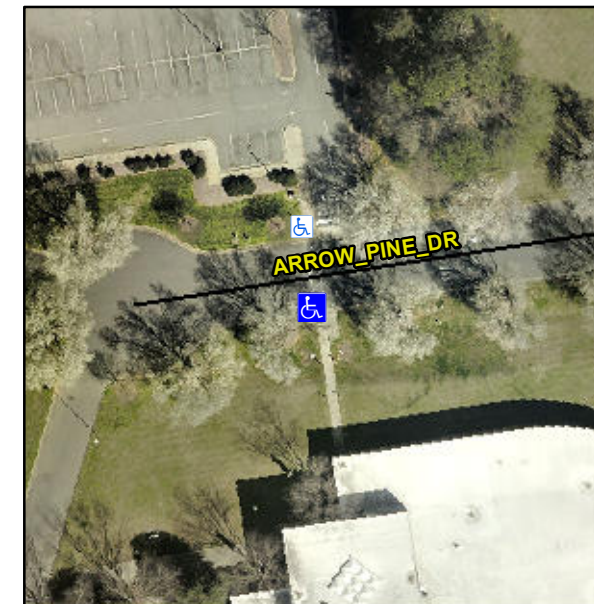
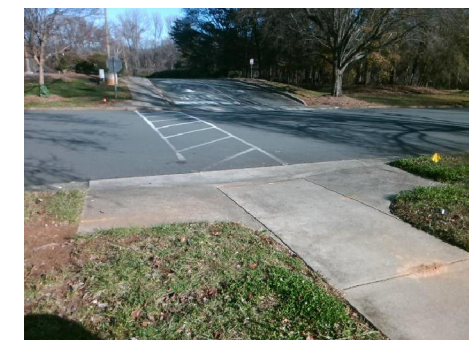
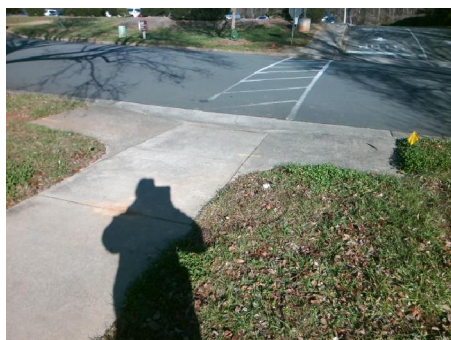
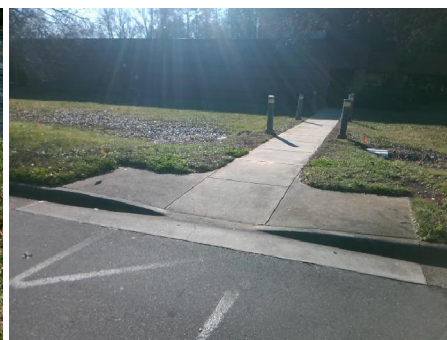
Compliance	Description	Data	Compliance	Description	Data
N/A	Ramp Length (in)	60.0	Yes	Ramp Slope (%)	7.7
Yes	Ramp Width (in)	58.0	Yes	Ramp XSlope (%)	0.9
N/A	Flare Type LT	Sloped	N/A	Flare Type RT	N/A
N/A	Flare Slope LT (%)	9.6	N/A	Flare Slope RT (%)	11.1
N/A	Flare Traversable LT?	No	N/A	Flare Traversable RT?	No
Yes	Landing Length (in)	58.5	No	DWS Provided?	No
Yes	Landing Width (in)	58.0	N/A	DWS Contrast?	No
Yes	Landing Slope (%)	0.8	N/A	DWS Length (in)	N/A
Yes	Landing X Slope (%)	1.8	N/A	DWS Full Width?	No
N/A	Landing Curb? (Y/N)	No	N/A	DWS Offset (in)	N/A
N/A	Shared Landing?	No			
Yes	Gutter Ponding?	No	No	Gutter Slope (%)	5.7
Yes	Gutter Lip Ht (in)	0.0	Yes	Gutter X Slope (%)	1.1
N/A	Painted X Walk1?	Yes	N/A	Painted X Walk2?	N/A
	X Walk 1 Direction	To N		X Walk 2 Direction	N/A
N/A	X Walk 1 Width (in)	65.5	N/A	X Walk 2 Width (in)	N/A
	X Walk 1 Slope (%)	4.4		X Walk 2 Slope (%)	N/A
	X Walk 1 X Slope (%)	1.4		X Walk 2 X Slope (%)	N/A

Yes	Ramp inside XWalk1?	Yes	N/A	Ramp inside XWalk2?	N/A
	Road Slope (%)	N/A	N/A	Clear Space?	Yes
	Road X Slope (%)	N/A	N/A	Clear Space to XWalk (in)	N/A
Yes	Any Obstructions?	No	Yes	Storm Grate/Utility Hazard?	No
	Obstruction Type			Storm Grate/Utility Type	
		N/A			N/A
			Yes	Surface Condition? (G/P)	Good

**Install Detectable Warning System.  
Remove & Replace Gutter.**

**R305, R304.5.4**
