Access Compliance Report

Public Rights-of-Way

(Curb Ramps)

Intersection ID: 15070	Main Street: IDEAL_WY	Cross Street: REMOUNT_RD	Location: E
ADA ID: 8B38783F04C5	Ramp Type: Perp	Initial Pass/Fail: Fail	Overall Compliance: No
Severity Score: 58.75			
Codes/Mitigation Info/Possible Solution		Field Measurements/Component Compliance

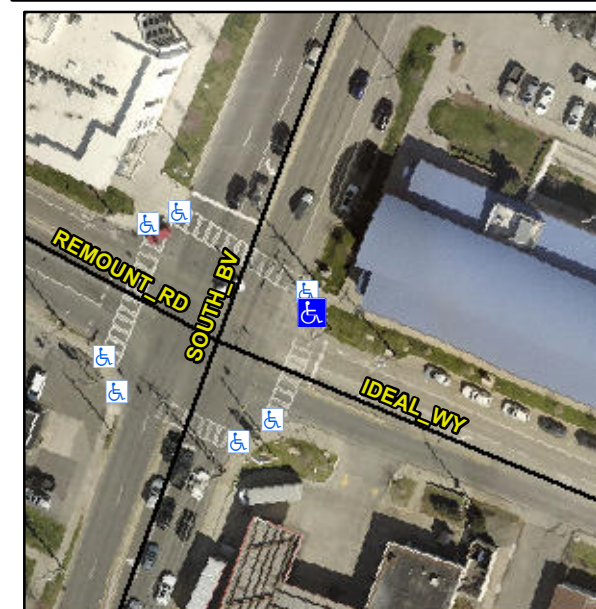
Not Found, R304.5.1, R304.2.2, R304.5.3

Compliance	Description	Data	Compliance	Description	Data
N/A	Ramp Length (in)	71.0	No	Ramp Slope (%)	16.1
No	Ramp Width (in)	47.0	No	Ramp XSlope (%)	8.3
N/A	Flare Type LT	N/A	N/A	Flare Type RT	N/A
N/A	Flare Slope LT (%)	N/A	N/A	Flare Slope RT (%)	N/A
N/A	Flare Traversable LT?	N/A	N/A	Flare Traversable RT?	N/A
N/A	Landing Length (in)	N/A	N/A	DWS Provided?	N/A
N/A	Landing Width (in)	N/A	N/A	DWS Contrast?	N/A
N/A	Landing Slope (%)	N/A	N/A	DWS Length (in)	N/A
N/A	Landing X Slope (%)	N/A	N/A	DWS Full Width?	N/A
N/A	Landing Curb? (Y/N)	N/A	N/A	DWS Offset (in)	N/A
N/A	Shared Landing?	N/A			
N/A	Gutter Ponding?	N/A	N/A	Gutter Slope (%)	N/A
N/A	Gutter Lip Ht (in)	N/A	N/A	Gutter X Slope (%)	N/A
N/A	Painted X Walk1?	Yes	N/A	Painted X Walk2?	N/A
	X Walk 1 Direction	To SW		X Walk 2 Direction	N/A
N/A	X Walk 1 Width (in)	116.0	N/A	X Walk 2 Width (in)	N/A
	X Walk 1 Slope (%)	1.5		X Walk 2 Slope (%)	N/A
	X Walk 1 X Slope (%)	9.1		X Walk 2 X Slope (%)	N/A

N/A	Ramp inside XWalk1?	Yes	N/A	Ramp inside XWalk2?	N/A
	Road Slope (%)	N/A	N/A	Clear Space?	N/A
	Road X Slope (%)	N/A	N/A	Clear Space to XWalk (in)	N/A
N/A	Any Obstructions?	N/A	N/A	Storm Grate/Utility Hazard?	N/A
	Obstruction Type			Storm Grate/Utility Type	
		N/A			N/A
		Yes		Surface Condition? (G/P)	Good

Possible Solutions:

Remove & Replace Entire Ramp.
