# Access Compliance Report

## Public Rights-of-Way

### (Curb Ramps)

| Intersection ID: 5855 | Main Street: W_SUGAR_CREEK_RD | Cross Street: NEVIN_RD | Location: S |

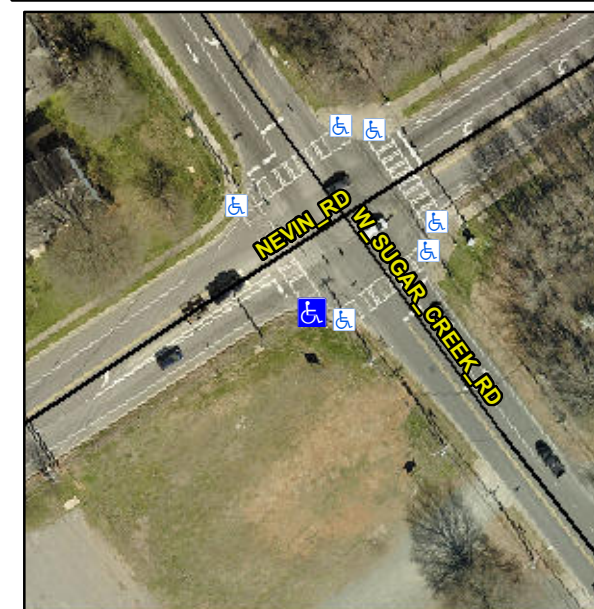
| ADA ID: 8B417DA79971 | Ramp Type: Perp | Initial Pass/Fail: Fail | Overall Compliance: No |
| Severity Score: 12.5 | | | |

**Not Found, R304.2.2**

| Compliance | Description | Data | Compliance | Description | Data |
|---|---|---|---|---|---|
| N/A | Ramp Length (in) | 61.0 | No | Ramp Slope (%) | 8.4 |
| Yes | Ramp Width (in) | 48.5 | Yes | Ramp XSlope (%) | 0.8 |

**Remove & Replace Entire Ramp.**

Total Cost: \$ 1850.00
