Access Compliance Report

Public Rights-of-Way

(Curb Ramps)

Intersection ID: 14692	Main Street: BAXTER_ST	Cross Street: QUEENS_RD	Location: NW
ADA ID: 8B42AF06B29D	Ramp Type: PerpDiag	Initial Pass/Fail: Fail	Overall Compliance: No
Severity Score: 12.5			
Codes/Mitigation Info/Possible Solution		Field Measurements/Component Compliance

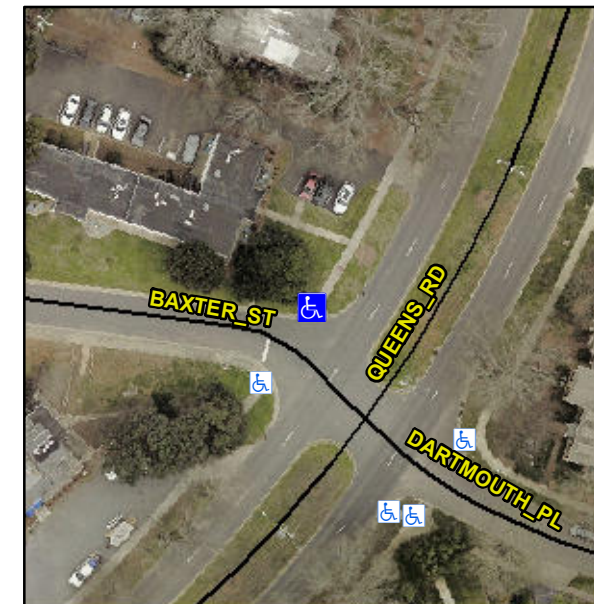
Compliance	Description	Data	Compliance	Description	Data
N/A	Ramp Length (in)	90.0	No	Ramp Slope (%)	10.5
Yes	Ramp Width (in)	48.0	Yes	Ramp XSlope (%)	1.8
N/A	Flare Type LT	N/A	N/A	Flare Type RT	N/A
N/A	Flare Slope LT (%)	N/A	N/A	Flare Slope RT (%)	N/A
N/A	Flare Traversable LT?	N/A	N/A	Flare Traversable RT?	N/A
N/A	Landing Length (in)	N/A	N/A	DWS Provided?	N/A
N/A	Landing Width (in)	N/A	N/A	DWS Contrast?	N/A
N/A	Landing Slope (%)	N/A	N/A	DWS Length (in)	N/A
N/A	Landing X Slope (%)	N/A	N/A	DWS Full Width?	N/A
N/A	Landing Curb? (Y/N)	N/A	N/A	DWS Offset (in)	N/A
N/A	Shared Landing?	N/A			
N/A	Gutter Ponding?	N/A	N/A	Gutter Slope (%)	N/A
N/A	Gutter Lip Ht (in)	N/A	N/A	Gutter X Slope (%)	N/A
N/A	Painted X Walk1?	No	N/A	Painted X Walk2?	No
	X Walk 1 Direction	To SW		X Walk 2 Direction	To SE
N/A	X Walk 1 Width (in)	N/A	N/A	X Walk 2 Width (in)	N/A
	X Walk 1 Slope (%)	2.1		X Walk 2 Slope (%)	4.4
	X Walk 1 X Slope (%)	3.1		X Walk 2 X Slope (%)	4.1

N/A	Ramp inside XWalk1?	N/A	N/A	Ramp inside XWalk2?	N/A
	Road Slope (%)	1.9	N/A	Clear Space?	N/A
	Road X Slope (%)	4.1	N/A	Clear Space to XWalk (in)	N/A
N/A	Any Obstructions?	N/A	N/A	Storm Grate/Utility Hazard?	N/A
	Obstruction Type			Storm Grate/Utility Type	
		N/A			N/A
		Yes		Surface Condition? (G/P)	Good

Possible Solutions:

Remove & Replace Curb Ramp With Two New Directional Ramps or Equivalent.

R304.2.2

\$ 3200.00
