Access Compliance Report

Public Rights-of-Way (Curb Ramps)

Intersection ID: 9317	Main Street: JUDSON_AV	Cross Street: W_TRADE_ST	Location: S
ADA ID: 8B468E81217A	Ramp Type: Perp	Initial Pass/Fail: Fail	Overall Compliance: No
		Severity Score: 8.75

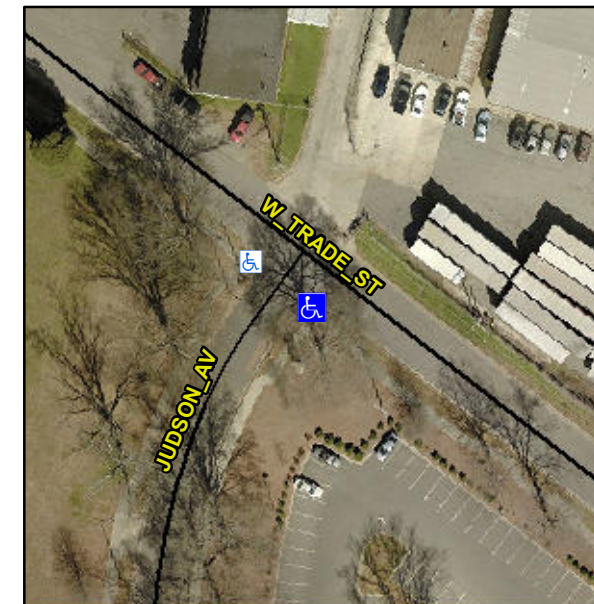
Not Found, R304.5.1

Compliance	Description	Data	Compliance	Description	Data
N/A	Ramp Length (in)	75.0	Yes	Ramp Slope (%)	5.7
No	Ramp Width (in)	46.5	Yes	Ramp XSlope (%)	0.3
N/A	Flare Type LT	N/A	N/A	Flare Type RT	N/A
N/A	Flare Slope LT (%)	N/A	N/A	Flare Slope RT (%)	N/A
N/A	Flare Traversable LT?	N/A	N/A	Flare Traversable RT?	N/A
N/A	Landing Length (in)	N/A	N/A	DWS Provided?	N/A
N/A	Landing Width (in)	N/A	N/A	DWS Contrast?	N/A
N/A	Landing Slope (%)	N/A	N/A	DWS Length (in)	N/A
N/A	Landing X Slope (%)	N/A	N/A	DWS Full Width?	N/A
N/A	Landing Curb? (Y/N)	N/A	N/A	DWS Offset (in)	N/A
N/A	Shared Landing?	N/A			
N/A	Gutter Ponding?	N/A	N/A	Gutter Slope (%)	N/A
N/A	Gutter Lip Ht (in)	0.5	N/A	Gutter X Slope (%)	N/A
N/A	Painted X Walk1?	No	N/A	Painted X Walk2?	N/A
	X Walk 1 Direction	To NW		X Walk 2 Direction	N/A
N/A	X Walk 1 Width (in)	N/A	N/A	X Walk 2 Width (in)	N/A
	X Walk 1 Slope (%)	3.4		X Walk 2 Slope (%)	N/A
	X Walk 1 X Slope (%)	0.3		X Walk 2 X Slope (%)	N/A

N/A	Ramp inside XWalk1?	N/A	N/A	Ramp inside XWalk2?	N/A
	Road Slope (%)	N/A	N/A	Clear Space?	N/A
	Road X Slope (%)	N/A	N/A	Clear Space to XWalk (in)	N/A
N/A	Any Obstructions?	N/A	N/A	Storm Grate/Utility Hazard?	N/A
	Obstruction Type			Storm Grate/Utility Type	
		N/A			N/A
			Yes	Surface Condition? (G/P)	Good

Remove & Replace Entire Ramp.

Total Cost: \$ 1850.00
