Access Compliance Report

Public Rights-of-Way

(Curb Ramps)

Intersection ID: 2990	Main Street: THOMAS_RIDGE_DR	Cross Street: PROSPERITY_RIDGE_RD	Location: NE
ADA ID: 8B494955818D	Ramp Type: PerpDiag	Initial Pass/Fail: Fail	Overall Compliance: No
Codes/Mitigation Info/Possible Solution			Severity Score: 25
			Field Measurements/Component Compliance

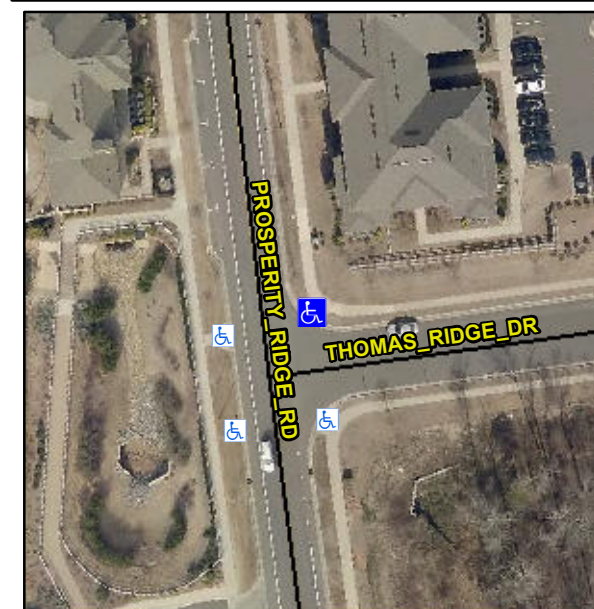
Compliance	Description	Data	Compliance	Description	Data
N/A	Ramp Length (in)	79.5	Yes	Ramp Slope (%)	6.4
Yes	Ramp Width (in)	48.0	No	Ramp XSlope (%)	9.2
N/A	Flare Type LT	N/A	N/A	Flare Type RT	N/A
N/A	Flare Slope LT (%)	N/A	N/A	Flare Slope RT (%)	N/A
N/A	Flare Traversable LT?	N/A	N/A	Flare Traversable RT?	N/A
N/A	Landing Length (in)	N/A	N/A	DWS Provided?	N/A
N/A	Landing Width (in)	N/A	N/A	DWS Contrast?	N/A
N/A	Landing Slope (%)	N/A	N/A	DWS Length (in)	N/A
N/A	Landing X Slope (%)	N/A	N/A	DWS Full Width?	N/A
N/A	Landing Curb? (Y/N)	N/A	N/A	DWS Offset (in)	N/A
N/A	Shared Landing?	N/A			
N/A	Gutter Ponding?	N/A	N/A	Gutter Slope (%)	N/A
N/A	Gutter Lip Ht (in)	N/A	N/A	Gutter X Slope (%)	N/A
N/A	Painted X Walk1?	No	N/A	Painted X Walk2?	No
	X Walk 1 Direction	To W		X Walk 2 Direction	To S
N/A	X Walk 1 Width (in)	N/A	N/A	X Walk 2 Width (in)	N/A
	X Walk 1 Slope (%)	7.1		X Walk 2 Slope (%)	3.4
	X Walk 1 X Slope (%)	3.1		X Walk 2 X Slope (%)	8.4

N/A	Ramp inside XWalk1?	N/A	N/A	Ramp inside XWalk2?	N/A
	Road Slope (%)	6.6	N/A	Clear Space?	N/A
	Road X Slope (%)	2.3	N/A	Clear Space to XWalk (in)	N/A
N/A	Any Obstructions?	N/A	N/A	Storm Grate/Utility Hazard?	N/A
	Obstruction Type			Storm Grate/Utility Type	
		N/A			N/A
			Yes	Surface Condition? (G/P)	Good

Remove & Replace Curb Ramp With Two New Directional Ramps or Equivalent.

R304.5.3

Total Cost: \$ 3200.00
