Access Compliance Report

Public Rights-of-Way

(Curb Ramps)

Intersection ID: 18032	Main Street: CHASTAIN_AV	Cross Street: SPRINGBROOK_RD	Location: NE
ADA ID: 8B5380FEB76B	Ramp Type: Perp	Initial Pass/Fail: Fail	Overall Compliance: No
			Severity Score: 26.25

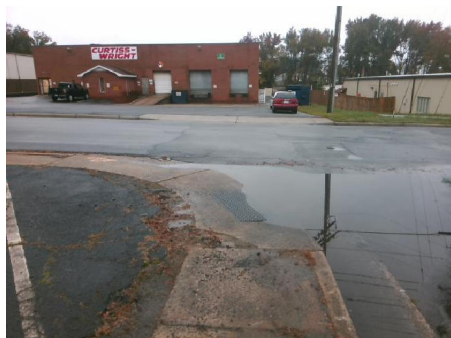
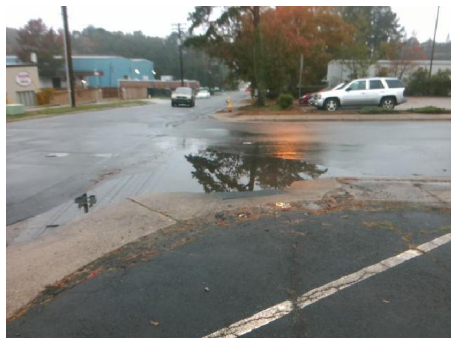
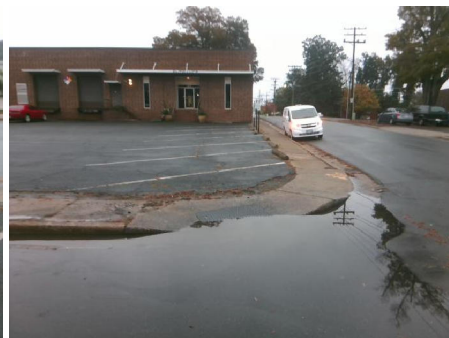
Possible Solutions:		Compliance	Description	Data
	Remove & Replace Entire Ramp.		No	Ramp Length (in)	51.5
			Yes	Ramp Width (in)	48.0
			N/A	Flare Type LT	N/A
			N/A	Flare Slope LT (%)	N/A
			N/A	Flare Traversable LT?	N/A
			N/A	Landing Length (in)	N/A
			N/A	Landing Width (in)	N/A
			N/A	Landing Slope (%)	N/A
			N/A	Landing X Slope (%)	N/A
<p>Surveyor Notes:</p> <p>N/A</p> <p>PROW/ADA:</p> <p>R304.2.2, R304.5.3</p>			N/A	Flare Type RT	N/A
			N/A	Flare Slope RT (%)	N/A
			N/A	Flare Traversable RT?	N/A
			N/A	DWS Provided?	N/A
			N/A	DWS Contrast?	N/A
			N/A	DWS Length (in)	N/A
			N/A	DWS Full Width?	N/A
			N/A	DWS Offset (in)	N/A
			N/A	Gutter Ponding?	N/A
			N/A	Gutter Lip Ht (in)	N/A
<p>Total Cost:</p> <p>\$ 1850.00</p>			No	Painted X Walk2?	N/A
			To W	X Walk 2 Direction	N/A
			N/A	X Walk 2 Width (in)	N/A

0.4	X Walk 2 Slope (%)	N/A
			1.6	X Walk 2 X Slope (%)	N/A
			N/A	Ramp inside XWalk2?	N/A
			N/A	Clear Space?	N/A
			N/A	Clear Space to XWalk (in)	N/A
			N/A	Storm Grate/Utility Hazard?	N/A
			N/A	Storm Grate/Utility Type	N/A
			N/A		N/A
			Yes	Surface Condition? (G/P)	Good
