# Access Compliance Report

## Public Rights-of-Way

### (Curb Ramps)

| Intersection ID: 16139 | Main Street: BILTMORE_DR | Cross Street: CHEROKEE_RD | Location: E |

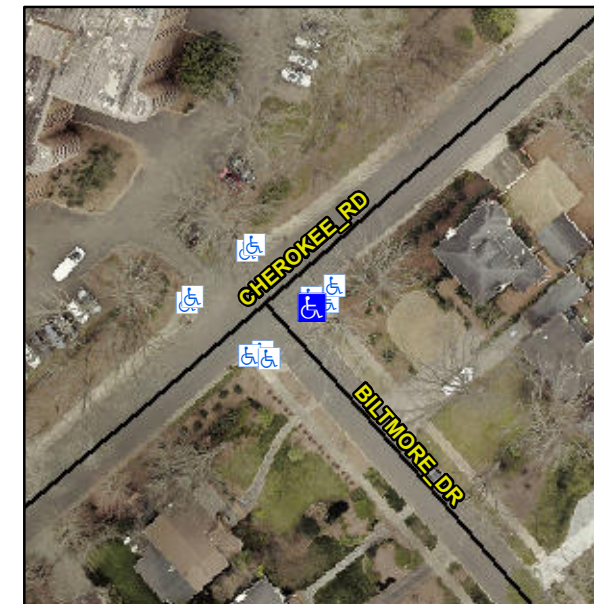
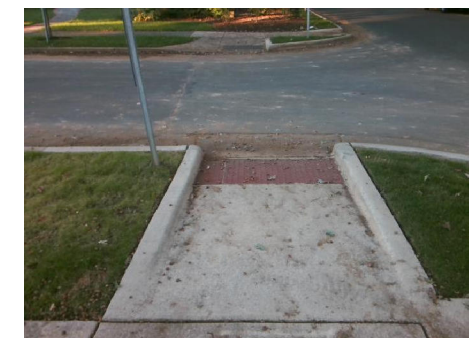
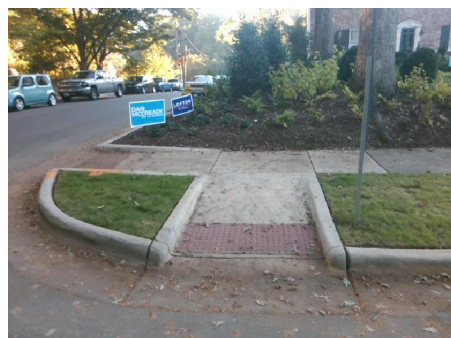
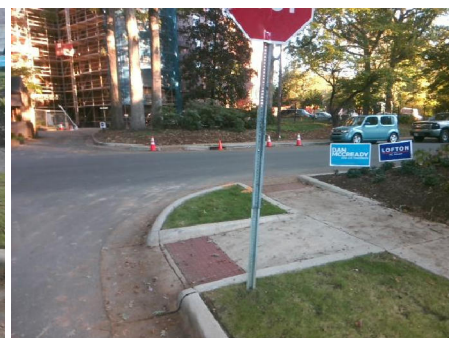
**Not Found, R304.2.2, R304.5.3**

| Compliance | Description | Data | Compliance | Description | Data |
|---|---|---|---|---|---|
| N/A | Ramp Length (in) | 92.0 | No | Ramp Slope (%) | 8.8 |
| Yes | Ramp Width (in) | 60.0 | No | Ramp XSlope (%) | 2.4 |

**Remove & Replace Entire Ramp.**
