Access Compliance Report

Public Rights-of-Way

(Curb Ramps)

Intersection ID: 32317	Main Street: BRIDGEVIEW_LN	Cross Street: NEW_PROVIDENCE_LN	Location: SW
ADA ID: 8B5A23561EDD	Ramp Type: BlendTrans1	Initial Pass/Fail: Fail	Overall Compliance: No
Severity Score: 21.25			
Codes/Mitigation Info/Possible Solution		Field Measurements/Component Compliance

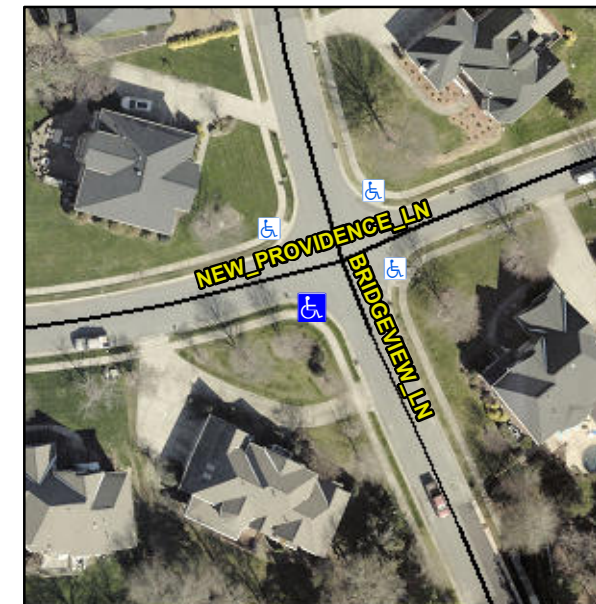
Not Found, R304.5.1, R304.5.3

Compliance	Description	Data	Compliance	Description	Data
N/A	Ramp Length (in)	47.5	Yes	BlendTrans Slope (%)	2.6
No	Ramp Width (in)	44.5	No	BlendTrans XSlope (%)	6.6
N/A	Flare Type LT	N/A	N/A	Flare Type RT	N/A
N/A	Flare Slope LT (%)	N/A	N/A	Flare Slope RT (%)	N/A
N/A	Flare Traversable LT?	N/A	N/A	Flare Traversable RT?	N/A
N/A	Landing Length (in)	N/A	N/A	DWS Provided?	N/A
N/A	Landing Width (in)	N/A	N/A	DWS Contrast?	N/A
N/A	Landing Slope (%)	N/A	N/A	DWS Length (in)	N/A
N/A	Landing X Slope (%)	N/A	N/A	DWS Full Width?	N/A
N/A	Landing Curb? (Y/N)	N/A	N/A	DWS Offset (in)	N/A
N/A	Shared Landing?	N/A			
N/A	Gutter Ponding?	N/A	N/A	Gutter Slope (%)	N/A
N/A	Gutter Lip Ht (in)	N/A	N/A	Gutter X Slope (%)	N/A
N/A	Painted X Walk1?	No	N/A	Painted X Walk2?	No
	X Walk 1 Direction	To NE		X Walk 2 Direction	To N
	X Walk 1 Width (in)	N/A		X Walk 2 Width (in)	N/A
	X Walk 1 Slope (%)	1.4		X Walk 2 Slope (%)	3.9
	X Walk 1 X Slope (%)	6.8		X Walk 2 X Slope (%)	0.2

N/A	Ramp inside XWalk1?	N/A	N/A	Ramp inside XWalk2?	N/A
	Road Slope (%)	6.0		Clear Space?	N/A
	Road X Slope (%)	4.6	N/A	Clear Space to XWalk (in)	N/A
N/A	Any Obstructions?	N/A	N/A	Storm Grate/Utility Hazard?	N/A
	Obstruction Type			Storm Grate/Utility Type	
		N/A			N/A
			Yes	Surface Condition? (G/P)	Good
			No	Curb Slope (%)	8.2

Remove & Replace Curb Ramp With Two New Directional Ramps or Equivalent.
