Access Compliance Report

Public Rights-of-Way

(Curb Ramps)

Intersection ID: N/A	Main Street: MORABLIN_DR	Cross Street: DURANT_BV	Location: NE
ADA ID: 8B62DFB3A647	Ramp Type: Perp	Initial Pass/Fail: Fail	Overall Compliance: No
			Severity Score: 46.25

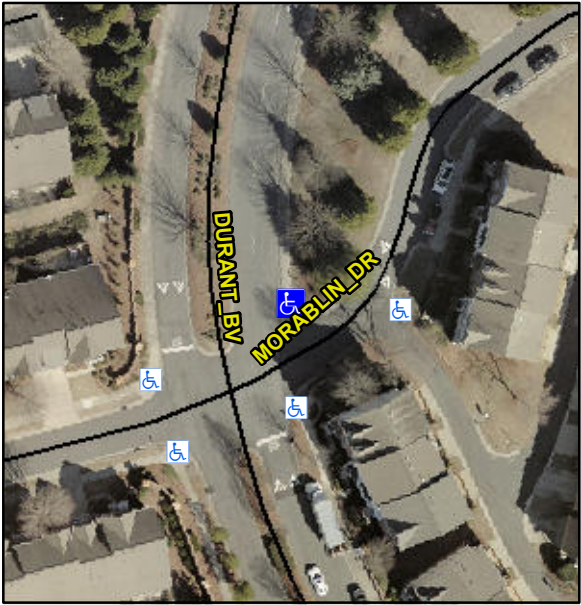
Possible Solutions:		Compliance	Description	Data
	Remove & Replace Entire Ramp.		No	Ramp Length (in)	59.0
			No	Ramp Width (in)	38.0
			N/A	Flare Type LT	N/A
			N/A	Flare Slope LT (%)	N/A
			N/A	Flare Traversable LT?	N/A
			N/A	Landing Length (in)	N/A
			N/A	Landing Width (in)	N/A
			N/A	Landing Slope (%)	N/A
			N/A	Landing X Slope (%)	N/A
<p>Surveyor Notes:</p> <p>N/A</p> <p>PROW/ADA:</p> <p>Not Found, R304.5.1, R304.2.2, R304.5.3</p>			N/A	Flare Type RT	N/A
			N/A	Flare Slope RT (%)	N/A
			N/A	Flare Traversable RT?	N/A
			N/A	DWS Provided?	N/A
			N/A	DWS Contrast?	N/A
			N/A	DWS Length (in)	N/A
			N/A	DWS Full Width?	N/A
			N/A	DWS Offset (in)	N/A
			N/A	Gutter Ponding?	N/A
			N/A	Gutter Lip Ht (in)	N/A
<p>Total Cost:</p> <p>\$ 1850.00</p>			No	Painted X Walk1?	N/A
			To S	X Walk 2 Direction	N/A
			N/A	X Walk 2 Width (in)	N/A

5.1	X Walk 2 Slope (%)	N/A
			16.2	X Walk 2 X Slope (%)	N/A
			N/A	Ramp inside XWalk1?	N/A
			N/A	Ramp inside XWalk2?	N/A
			N/A	Clear Space?	N/A
			N/A	Clear Space to XWalk (in)	N/A
			N/A	Storm Grate/Utility Hazard?	N/A
			N/A	Obstruction Type	N/A
			N/A	Storm Grate/Utility Type	N/A
			Yes	Surface Condition? (G/P)	Good
