Access Compliance Report

Public Rights-of-Way

(Curb Ramps)

Intersection ID: 4743	Main Street: BELLHAVEN_BV	Cross Street: MT_HOLLY-HUNTERSVILLE_RD	Location: S
ADA ID: 8B7665F67AC9	Ramp Type: Para	Initial Pass/Fail: Fail	Overall Compliance: No
Codes/Mitigation Info/Possible Solution		Field Measurements/Component Compliance	
Severity Score: 13.75

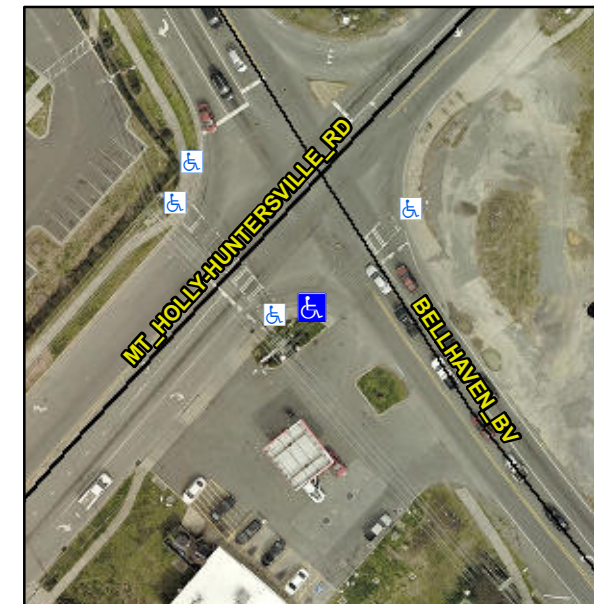
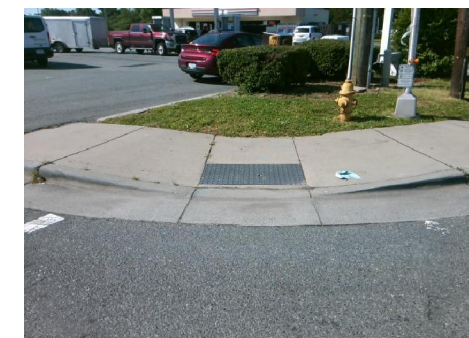
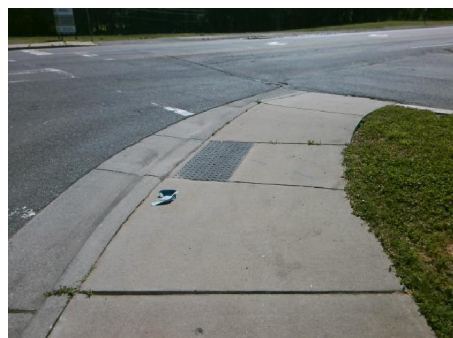
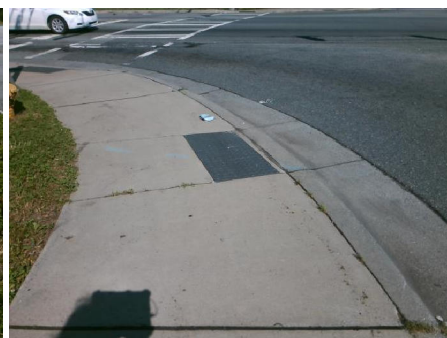
RT RP < 5%

R304.3.2, R304.5.3

Compliance	Description	Data	Compliance	Description	Data
N/A	Ramp Length LT (in)	46.0	N/A	Ramp Length RT (in)	52.0
Yes	Ramp Width LT (in)	72.0	Yes	Ramp Width RT (in)	72.0
No	Ramp Slope LT (%)	8.8	Yes	Ramp Slope RT (%)	4.1
No	Ramp XSlope LT (%)	3.7	No	Ramp XSlope RT (%)	3.7
N/A	Landing Length (in)	N/A	N/A	DWS Provided?	N/A
N/A	Landing Width (in)	N/A	N/A	DWS Contrast?	N/A
N/A	Landing Slope (%)	N/A	N/A	DWS Length (in)	N/A
N/A	Landing X Slope (%)	N/A	N/A	DWS Full Width?	N/A
N/A	Landing Curb? (Y/N)	N/A	N/A	DWS Offset (in)	N/A
N/A	Shared Landing?	N/A			
N/A	Gutter Ponding?	N/A	N/A	Gutter Slope (%)	N/A
N/A	Gutter Lip Ht (in)	N/A	N/A	Gutter X Slope (%)	N/A
N/A	Painted X Walk1?	No	N/A	Painted X Walk2?	N/A
	X Walk 1 Direction	To NE		X Walk 2 Direction	N/A
N/A	X Walk 1 Width (in)	N/A	N/A	X Walk 2 Width (in)	N/A
	X Walk 1 Slope (%)	5.6		X Walk 2 Slope (%)	N/A
	X Walk 1 X Slope (%)	1.2		X Walk 2 X Slope (%)	N/A
N/A	Ramp inside XWalk1?	N/A	N/A	Ramp inside XWalk2?	N/A

Road Slope (%)	N/A	N/A	Clear Space?	N/A
	Road X Slope (%)	N/A	N/A	Clear Space to XWalk (in)	N/A
N/A	Any Obstructions?	N/A	N/A	Storm Grate/Utility Hazard?	N/A
	Obstruction Type			Storm Grate/Utility Type	
		N/A			N/A
			Yes	Surface Condition? (G/P)	Good
			N/A	Curb Slope (%)	11.2

Possible Solutions:

Remove & Replace Entire Ramp.

Total Cost: \$ 1600.00
