Access Compliance Report

Public Rights-of-Way

(Curb Ramps)

Intersection ID: 12194	Main Street: S_CEDAR_ST	Cross Street: W_HILL_ST	Location: S
ADA ID: 8B7CB107D42D	Ramp Type: PerpDiag	Initial Pass/Fail: Pass	Overall Compliance: No
Severity Score: 2.75			
Codes/Mitigation Info/Possible Solution		Field Measurements/Component Compliance

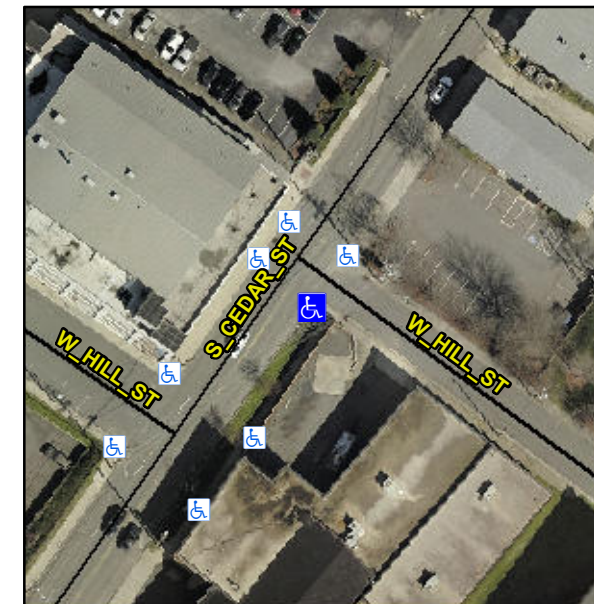
Not Found, R304.5.3, R304.2.2-Perp, R304.3.2-Para, R305.1.4, R305.2

Compliance	Description	Data	Compliance	Description	Data
N/A	Ramp Length (in)	62.0	Yes	Ramp Slope (%)	5.9
Yes	Ramp Width (in)	60.0	No	Ramp XSlope (%)	3.2
N/A	Flare Type LT	Sloped	N/A	Flare Type RT	N/A
N/A	Flare Slope LT (%)	8.5	Yes	Flare Slope RT (%)	0.7
N/A	Flare Traversable LT?	Yes	N/A	Flare Traversable RT?	Yes
Yes	Landing Length (in)	60.0	Yes	DWS Provided?	Yes
Yes	Landing Width (in)	60.0	Yes	DWS Contrast?	Yes
No	Landing Slope (%)	5.0	Yes	DWS Length (in)	24.0
No	Landing X Slope (%)	3.3	No	DWS Full Width?	No
N/A	Landing Curb? (Y/N)	No	No	DWS Offset (in)	4.5
N/A	Shared Landing?	Yes			
Yes	Gutter Ponding?	No	Yes	Gutter Slope (%)	1.7
Yes	Gutter Lip Ht (in)	0.0	No	Gutter X Slope (%)	2.5
N/A	Painted X Walk1?	No	N/A	Painted X Walk2?	No
	X Walk 1 Direction	To NE		X Walk 2 Direction	To NW
N/A	X Walk 1 Width (in)	N/A	N/A	X Walk 2 Width (in)	N/A
	X Walk 1 Slope (%)	3.6		X Walk 2 Slope (%)	5.2
	X Walk 1 X Slope (%)	2.1		X Walk 2 X Slope (%)	1.2

N/A	Ramp inside XWalk1?	N/A	N/A	Ramp inside XWalk2?	N/A
	Road Slope (%)	0.9	N/A	Clear Space?	Yes
	Road X Slope (%)	1.0	N/A	Clear Space to XWalk (in)	N/A
Yes	Any Obstructions?	No	Yes	Storm Grate/Utility Hazard?	No
	Obstruction Type			Storm Grate/Utility Type	
		N/A			N/A
		Yes	Yes	Surface Condition? (G/P)	Good

Remove & Replace Curb Ramp With Two New Directional Ramps or Equivalent. Remove & Replace Gutter.
