Access Compliance Report

Public Rights-of-Way

(Curb Ramps)

Intersection ID: 23547	Main Street: CASTLEGATE_DR	Cross Street: KNIGHTSWOOD_DR	Location: SE
ADA ID: 8B7F84A7545B	Ramp Type: PerpDiag	Initial Pass/Fail: Fail	Overall Compliance: No
Severity Score: 21.25			
Codes/Mitigation Info/Possible Solution		Field Measurements/Component Compliance

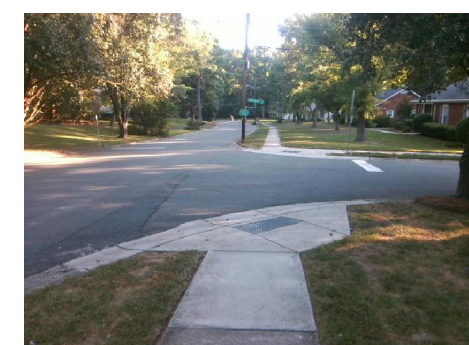
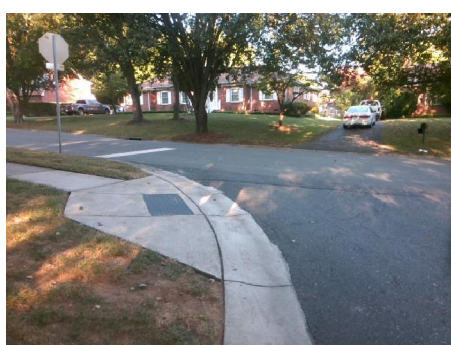
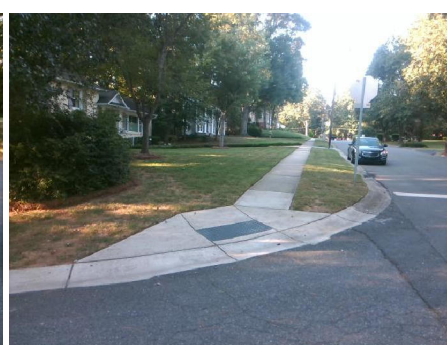
Not Found, R304.5.1, R304.5.3

Compliance	Description	Data	Compliance	Description	Data
N/A	Ramp Length (in)	72.0	Yes	Ramp Slope (%)	7.7
No	Ramp Width (in)	47.0	No	Ramp XSlope (%)	6.4
N/A	Flare Type LT	N/A	N/A	Flare Type RT	N/A
N/A	Flare Slope LT (%)	N/A	N/A	Flare Slope RT (%)	N/A
N/A	Flare Traversable LT?	N/A	N/A	Flare Traversable RT?	N/A
N/A	Landing Length (in)	N/A	N/A	DWS Provided?	N/A
N/A	Landing Width (in)	N/A	N/A	DWS Contrast?	N/A
N/A	Landing Slope (%)	N/A	N/A	DWS Length (in)	N/A
N/A	Landing X Slope (%)	N/A	N/A	DWS Full Width?	N/A
N/A	Landing Curb? (Y/N)	N/A	N/A	DWS Offset (in)	N/A
N/A	Shared Landing?	N/A			
N/A	Gutter Ponding?	N/A	N/A	Gutter Slope (%)	N/A
N/A	Gutter Lip Ht (in)	N/A	N/A	Gutter X Slope (%)	N/A
N/A	Painted X Walk1?	No	N/A	Painted X Walk2?	No
	X Walk 1 Direction	To NE		X Walk 2 Direction	To W
N/A	X Walk 1 Width (in)	N/A	N/A	X Walk 2 Width (in)	N/A
	X Walk 1 Slope (%)	4.4		X Walk 2 Slope (%)	5.0
	X Walk 1 X Slope (%)	5.8		X Walk 2 X Slope (%)	5.4

N/A	Ramp inside XWalk1?	N/A	N/A	Ramp inside XWalk2?	N/A
	Road Slope (%)	6.5	N/A	Clear Space?	N/A
	Road X Slope (%)	1.8	N/A	Clear Space to XWalk (in)	N/A
N/A	Any Obstructions?	N/A	N/A	Storm Grate/Utility Hazard?	N/A
	Obstruction Type			Storm Grate/Utility Type	
		N/A			N/A
		Yes		Surface Condition? (G/P)	Good

Remove & Replace Curb Ramp With Two New Directional Ramps or Equivalent.
