Access Compliance Report

Public Rights-of-Way

(Curb Ramps)

Intersection ID: N/A	Main Street: SHARON_VIEW_RD	Cross Street: OHILLIOS_GATE_DR	Location: NE
ADA ID: 8B8DF4D30B9E	Ramp Type: BlendTrans2	Initial Pass/Fail: Fail	Overall Compliance: No
		Severity Score: 1.25

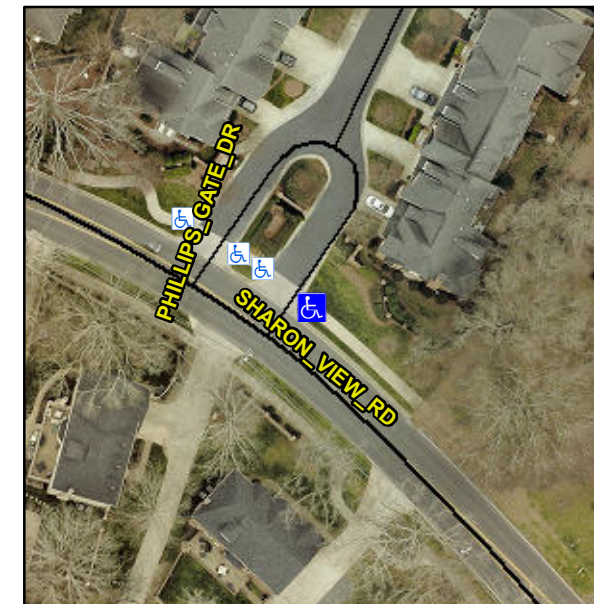
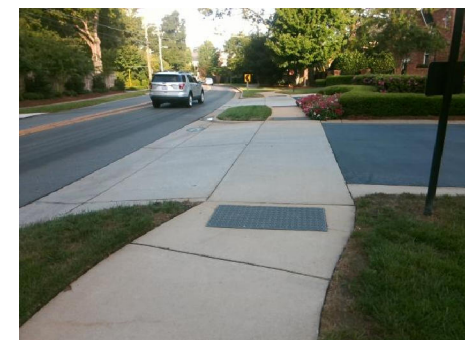
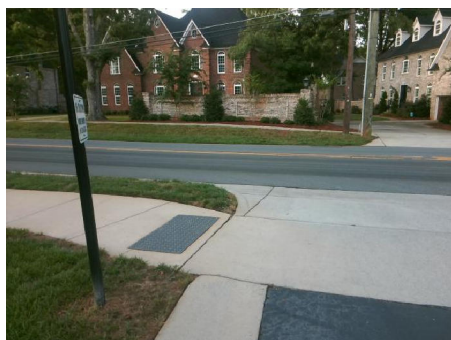
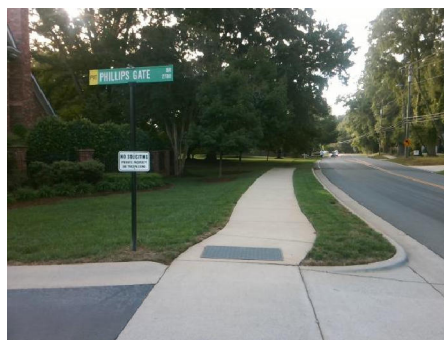
Compliance	Description	Data	Compliance	Description	Data
N/A	Ramp Length (in)	50.0	Yes	BlendTrans Slope (%)	1.6
Yes	Ramp Width (in)	48.0	No	BlendTrans XSlope (%)	2.2
N/A	Flare Type LT	N/A	N/A	Flare Type RT	N/A
N/A	Flare Slope LT (%)	N/A	N/A	Flare Slope RT (%)	N/A
N/A	Flare Traversable LT?	N/A	N/A	Flare Traversable RT?	N/A
N/A	Landing Length (in)	N/A	N/A	DWS Provided?	N/A
N/A	Landing Width (in)	N/A	N/A	DWS Contrast?	N/A
N/A	Landing Slope (%)	N/A	N/A	DWS Length (in)	N/A
N/A	Landing X Slope (%)	N/A	N/A	DWS Full Width?	N/A
N/A	Landing Curb? (Y/N)	N/A	N/A	DWS Offset (in)	N/A
N/A	Shared Landing?	N/A			
N/A	Gutter Ponding?	N/A	N/A	Gutter Slope (%)	N/A
N/A	Gutter Lip Ht (in)	N/A	N/A	Gutter X Slope (%)	N/A
N/A	Painted X Walk1?	No	N/A	Painted X Walk2?	N/A
	X Walk 1 Direction	To NW		X Walk 2 Direction	N/A
	X Walk 1 Width (in)	N/A		X Walk 2 Width (in)	N/A
	X Walk 1 Slope (%)	0.5		X Walk 2 Slope (%)	N/A
	X Walk 1 X Slope (%)	1.6		X Walk 2 X Slope (%)	N/A

N/A	Ramp inside XWalk1?	N/A	N/A	Ramp inside XWalk2?	N/A
	Road Slope (%)	1.6		Clear Space?	N/A
	Road X Slope (%)	0.5	N/A	Clear Space to XWalk (in)	N/A
N/A	Any Obstructions?	N/A	N/A	Storm Grate/Utility Hazard?	N/A
	Obstruction Type			Storm Grate/Utility Type	
		N/A			N/A
			Yes	Surface Condition? (G/P)	Good
			N/A	Curb Slope (%)	2.4

Remove & Replace Curb Ramp With Two New Directional Ramps or Equivalent.

R304.5.3
