# Access Compliance Report

## Public Rights-of-Way

### (Curb Ramps)

Intersection ID: N/A	Main Street: NATIONS_FORD_RD	Cross Street: IVERIFY	Location: NE
ADA ID: 8B97A75FF9A1	Ramp Type: ParaDiag	Initial Pass/Fail: Fail	Overall Compliance: No
Codes/Mitigation Info/Possible Solution		Field Measurements/Component Compliance

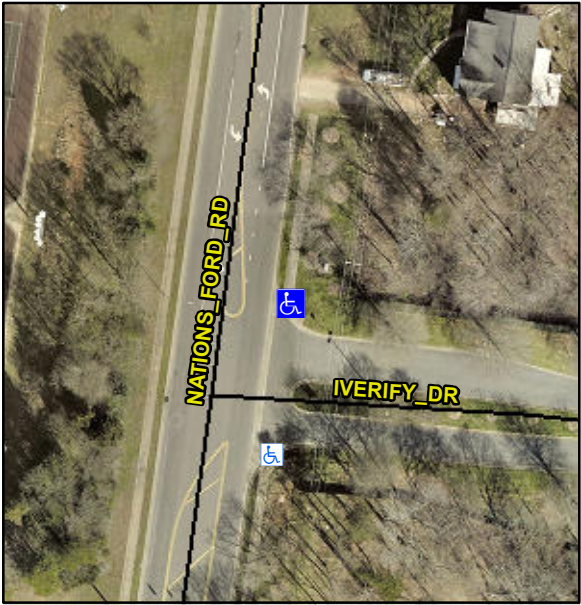
Possible Solutions:		Compliance		Description		Data	Compliance	Description	Data
	Remove & Replace Curb Ramp With Two New Directional Ramps or Equivalent.		N/A		Ramp Length LT (in)		51.0	N/A	Ramp Length RT (in)	61.0
<p>Surveyor Notes:</p> <p>RT RP &lt; 5%</p>			Yes		Ramp Width LT (in)		75.0	Yes	Ramp Width RT (in)	65.0
			No		Ramp Slope LT (%)		12.9	Yes	Ramp Slope RT (%)	2.6
<p>PROW/ADA:</p> <p>R304.3.2, R304.5.3</p>			No		Ramp XSlope LT (%)		2.3	No	Ramp XSlope RT (%)	4.5
			N/A		Landing Length (in)		N/A	N/A	DWS Provided?	N/A
			N/A		Landing Width (in)		N/A	N/A	DWS Contrast?	N/A
			N/A		Landing Slope (%)		N/A	N/A	DWS Length (in)	N/A
			N/A		Landing X Slope (%)		N/A	N/A	DWS Full Width?	N/A
			N/A		Landing Curb? (Y/N)		N/A	N/A	DWS Offset (in)	N/A
			N/A		Shared Landing?		N/A			
			N/A		Gutter Ponding?		N/A	N/A	Gutter Slope (%)	N/A
			N/A		Gutter Lip Ht (in)		N/A	N/A	Gutter X Slope (%)	N/A
			N/A		Painted X Walk1?		No	N/A	Painted X Walk2?	No

X Walk 1 Direction		To W		X Walk 2 Direction	To S
			N/A		X Walk 1 Width (in)		N/A	N/A	X Walk 2 Width (in)	N/A
					X Walk 1 Slope (%)		2.3		X Walk 2 Slope (%)	1.9
					X Walk 1 X Slope (%)		0.2		X Walk 2 X Slope (%)	4.0
			N/A		Ramp inside XWalk1?		N/A	N/A	Ramp inside XWalk2?	N/A
					Road Slope (%)		0.0	N/A	Clear Space?	N/A
					Road X Slope (%)		4.3	N/A	Clear Space to XWalk (in)	N/A
			N/A		Any Obstructions?		N/A	N/A	Storm Grate/Utility Hazard?	N/A
					Obstruction Type				Storm Grate/Utility Type	
							N/A			N/A
								Yes	Surface Condition? (G/P)	Good
								N/A	Curb Slope (%)	7.6

Total Cost: \$ 3200.00
