Access Compliance Report

Public Rights-of-Way

(Curb Ramps)

Intersection ID: 29352	Main Street: OSAGE_CR	Cross Street: N/A	Location: E
ADA ID: 8B9903ED137A	Ramp Type: BlendTrans1	Initial Pass/Fail: Fail	Overall Compliance: No
Severity Score: 10			
Codes/Mitigation Info/Possible Solution		Field Measurements/Component Compliance

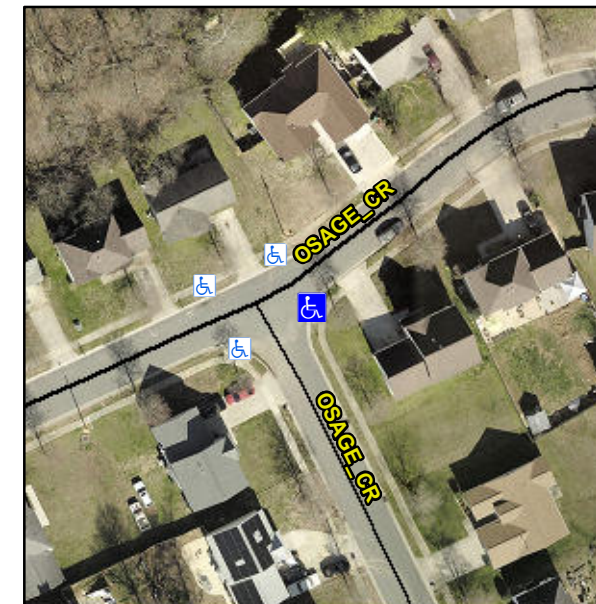
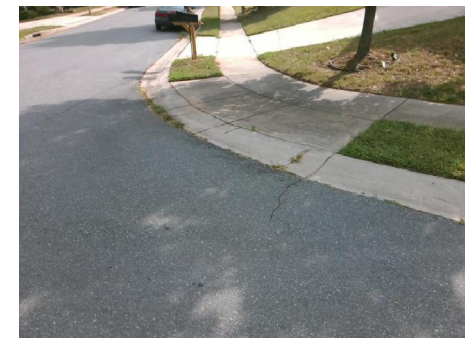
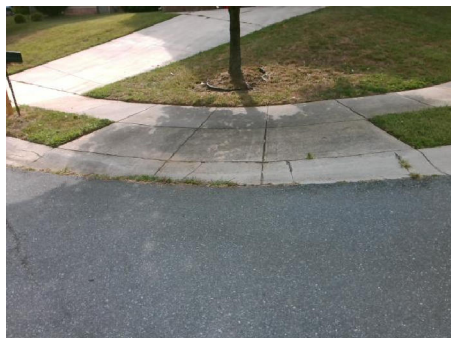
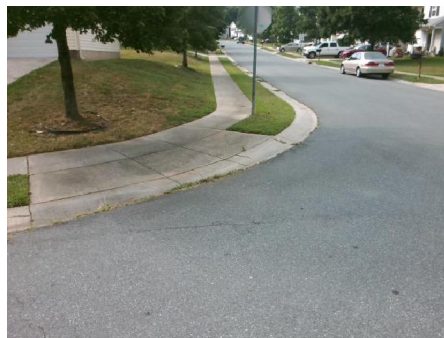
Not Found, R304.5.1, R304.5.3

Compliance	Description	Data	Compliance	Description	Data
N/A	Ramp Length (in)	49.0	Yes	BlendTrans Slope (%)	4.7
No	Ramp Width (in)	42.5	No	BlendTrans XSlope (%)	2.7
N/A	Flare Type LT	N/A	N/A	Flare Type RT	N/A
N/A	Flare Slope LT (%)	N/A	N/A	Flare Slope RT (%)	N/A
N/A	Flare Traversable LT?	N/A	N/A	Flare Traversable RT?	N/A
N/A	Landing Length (in)	N/A	N/A	DWS Provided?	N/A
N/A	Landing Width (in)	N/A	N/A	DWS Contrast?	N/A
N/A	Landing Slope (%)	N/A	N/A	DWS Length (in)	N/A
N/A	Landing X Slope (%)	N/A	N/A	DWS Full Width?	N/A
N/A	Landing Curb? (Y/N)	N/A	N/A	DWS Offset (in)	N/A
N/A	Shared Landing?	N/A			
N/A	Gutter Ponding?	N/A	N/A	Gutter Slope (%)	N/A
N/A	Gutter Lip Ht (in)	2.0	N/A	Gutter X Slope (%)	N/A
N/A	Painted X Walk1?	No	N/A	Painted X Walk2?	No
	X Walk 1 Direction	To NW		X Walk 2 Direction	To SW
	X Walk 1 Width (in)	N/A		X Walk 2 Width (in)	N/A
	X Walk 1 Slope (%)	0.9		X Walk 2 Slope (%)	0.7
	X Walk 1 X Slope (%)	0.3		X Walk 2 X Slope (%)	3.0

N/A	Ramp inside XWalk1?	N/A	N/A	Ramp inside XWalk2?	N/A
	Road Slope (%)	0.4		Clear Space?	N/A
	Road X Slope (%)	7.2	N/A	Clear Space to XWalk (in)	N/A
N/A	Any Obstructions?	N/A	N/A	Storm Grate/Utility Hazard?	N/A
	Obstruction Type			Storm Grate/Utility Type	
		N/A			N/A
			Yes	Surface Condition? (G/P)	Good
			No	Curb Slope (%)	13.0

Remove & Replace Curb Ramp With Two New Directional Ramps or Equivalent.
