Access Compliance Report Public Rights-of-Way (Curb Ramps)

Intersection ID: 47450 Main Street: PINTAIL LANDING LN **Cross Street: MALLARD LANDING RD** Location: NW ADA ID: 8BA4CE0F4B6B Ramp Type: Perp Initial Pass/Fail: Fail **Overall Compliance: No Severity Score:** 22.5

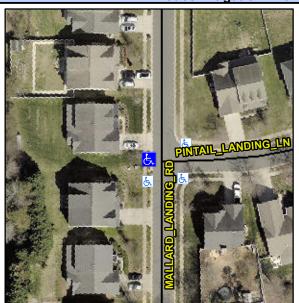
Street 1 Name	MALLARD LANDING RD
Stop Condition-Street 2	None
Street 2 Name	N/A
Stop Condition-Street 1	N/A

Possible Solutions: Compliance Description Remove & Replace Entire Ramp. N/A No N/A N/A N/A N/A Surveyor Notes: N/A
