# Access Compliance Report

## Public Rights-of-Way

### (Curb Ramps)

Intersection ID: 10018039	Main Street: MUNSING_DR	Cross Street: N/A	Location: N
ADA ID: 8BB591634E30	Ramp Type: Perp	Initial Pass/Fail: Fail	Overall Compliance: No
		Severity Score: 10

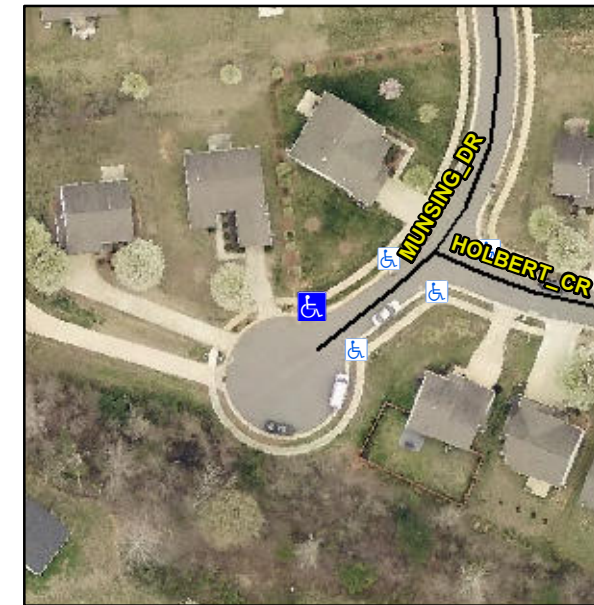
**Not Found, R304.5.1, R304.5.3**

Compliance	Description	Data	Compliance	Description	Data
N/A	Ramp Length (in)	48.0	Yes	Ramp Slope (%)	5.1
No	Ramp Width (in)	41.0	No	Ramp XSlope (%)	3.8
N/A	Flare Type LT	N/A	N/A	Flare Type RT	N/A
N/A	Flare Slope LT (%)	N/A	N/A	Flare Slope RT (%)	N/A
N/A	Flare Traversable LT?	N/A	N/A	Flare Traversable RT?	N/A
N/A	Landing Length (in)	N/A	N/A	DWS Provided?	N/A
N/A	Landing Width (in)	N/A	N/A	DWS Contrast?	N/A
N/A	Landing Slope (%)	N/A	N/A	DWS Length (in)	N/A
N/A	Landing X Slope (%)	N/A	N/A	DWS Full Width?	N/A
N/A	Landing Curb? (Y/N)	N/A	N/A	DWS Offset (in)	N/A
N/A	Shared Landing?	N/A			
N/A	Gutter Ponding?	N/A	N/A	Gutter Slope (%)	N/A
N/A	Gutter Lip Ht (in)	N/A	N/A	Gutter X Slope (%)	N/A
N/A	Painted X Walk1?	No	N/A	Painted X Walk2?	N/A
	X Walk 1 Direction	To S		X Walk 2 Direction	N/A
N/A	X Walk 1 Width (in)	N/A	N/A	X Walk 2 Width (in)	N/A
	X Walk 1 Slope (%)	6.0		X Walk 2 Slope (%)	N/A
	X Walk 1 X Slope (%)	0.7		X Walk 2 X Slope (%)	N/A

N/A	Ramp inside XWalk1?	N/A	N/A	Ramp inside XWalk2?	N/A
	Road Slope (%)	N/A	N/A	Clear Space?	N/A
	Road X Slope (%)	N/A	N/A	Clear Space to XWalk (in)	N/A
N/A	Any Obstructions?	N/A	N/A	Storm Grate/Utility Hazard?	N/A
	Obstruction Type			Storm Grate/Utility Type	
		N/A			N/A
			Yes	Surface Condition? (G/P)	Good

**Remove & Replace Entire Ramp.**

Total Cost: \$ 1850.00
