# Access Compliance Report

## Public Rights-of-Way

### (Curb Ramps)

| Intersection ID: 10033959 | Main Street: PARK_RD | Cross Street: N/A | Location: NE |

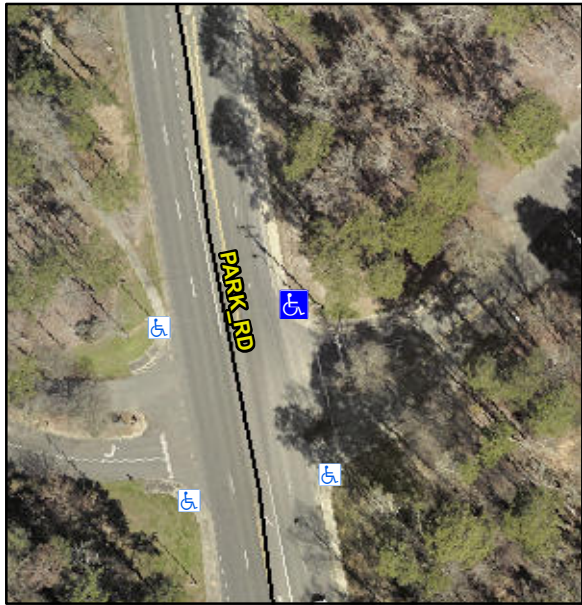
| ADA ID: 8BB8A8F47256 | Ramp Type: PerpDiag | Initial Pass/Fail: Fail | Overall Compliance: No |

| Codes/Mitigation Info/Possible Solution | | | Field Measurements/Component Compliance | | | | | |
|---|---|---|---|---|---|---|---|---|
| | Remove & Replace Curb Ramp With Two New Directional Ramps or Equivalent. | | N/A | Ramp Length (in) | 59.0 | No | Ramp Slope (%) | 8.6 |
| | | | Yes | Ramp Width (in) | 48.0 | No | Ramp XSlope (%) | 6.9 |

| Codes/Mitigation Info/Possible Solution | | | Field Measurements/Component Compliance | | | | | |
|---|---|---|---|---|---|---|---|---|
| Total Cost: | | \$ 3200.00 | | | | | | |
