Access Compliance Report

Public Rights-of-Way

(Curb Ramps)

Intersection ID: 9522	Main Street: MARLENE_ST	Cross Street: SANTEE_ST	Location:	N
ADA ID: 8BBC6B36BA61	Ramp Type: Perp	Initial Pass/Fail: Fail	Overall Compliance: No	Severity Score: 33.75
Codes/Mitigation Info/Possible Solution		Field Measurements/Component Compliance

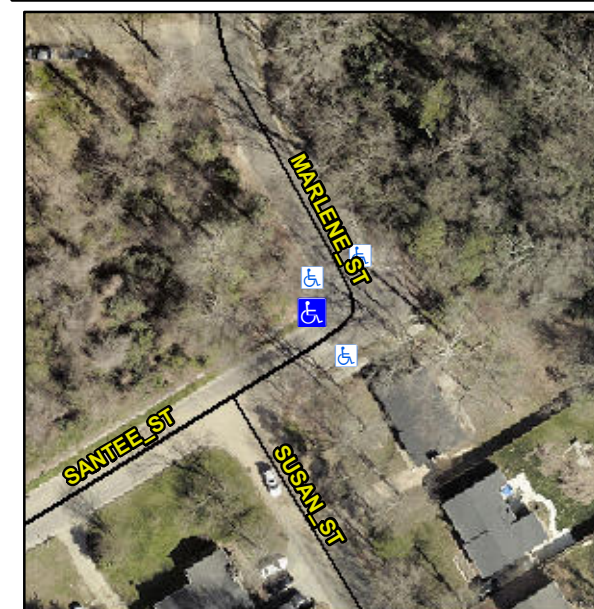
Not Found, R304.5.1, R304.2.2, R304.5.3

Compliance	Description	Data	Compliance	Description	Data
N/A	Ramp Length (in)	48.0	No	Ramp Slope (%)	11.1
No	Ramp Width (in)	47.5	No	Ramp XSlope (%)	6.7
N/A	Flare Type LT	N/A	N/A	Flare Type RT	N/A
N/A	Flare Slope LT (%)	N/A	N/A	Flare Slope RT (%)	N/A
N/A	Flare Traversable LT?	N/A	N/A	Flare Traversable RT?	N/A
N/A	Landing Length (in)	N/A	N/A	DWS Provided?	N/A
N/A	Landing Width (in)	N/A	N/A	DWS Contrast?	N/A
N/A	Landing Slope (%)	N/A	N/A	DWS Length (in)	N/A
N/A	Landing X Slope (%)	N/A	N/A	DWS Full Width?	N/A
N/A	Landing Curb? (Y/N)	N/A	N/A	DWS Offset (in)	N/A
N/A	Shared Landing?	N/A			
N/A	Gutter Ponding?	N/A	N/A	Gutter Slope (%)	N/A
N/A	Gutter Lip Ht (in)	0.5	N/A	Gutter X Slope (%)	N/A
N/A	Painted X Walk1?	No	N/A	Painted X Walk2?	N/A
	X Walk 1 Direction	To S		X Walk 2 Direction	N/A
N/A	X Walk 1 Width (in)	N/A	N/A	X Walk 2 Width (in)	N/A
	X Walk 1 Slope (%)	1.9		X Walk 2 Slope (%)	N/A
	X Walk 1 X Slope (%)	7.0		X Walk 2 X Slope (%)	N/A

N/A	Ramp inside XWalk1?	N/A	N/A	Ramp inside XWalk2?	N/A
	Road Slope (%)	N/A	N/A	Clear Space?	N/A
	Road X Slope (%)	N/A	N/A	Clear Space to XWalk (in)	N/A
N/A	Any Obstructions?	N/A	N/A	Storm Grate/Utility Hazard?	N/A
	Obstruction Type			Storm Grate/Utility Type	
		N/A			N/A
			Yes	Surface Condition? (G/P)	Good

Possible Solutions:

Remove & Replace Entire Ramp.
