## **Access Compliance Report Public Rights-of-Way** (Curb Ramps)

Intersection ID: 18166 Main Street: SCALEYBARK RD Cross Street: E WOODLAWN RD NE Location: **Overall Compliance: No Severity Score:** 0 ADA ID: 8BC94137A15A Ramp Type: Combination1Diag Initial Pass/Fail: Fail

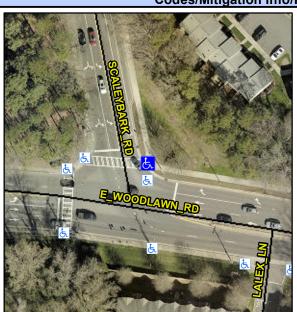
Total Cost: 3200.00 Compliance Description Data Compliance Description Data N/A N/A Ramp Length LT (in) 78.0 Ramp Length RT (in) 68.0 Yes Ramp Width LT (in) Yes Ramp Width RT (in) No Ramp Slope LT (%) 10.4 Yes Ramp Slope RT (%) Ramp XSlope LT (%) Yes Ramp XSlope RT (%) Yes 1.3 N/A Ramp Length (in) 25.0 Yes Ramp Slope (%) 99.0 Yes Ramp XSlope (%) Yes Ramp Width (in) N/A Flare Type LT N/A N/A Flare Type RT N/A N/A N/A Flare Slope LT (%) Flare Slope RT (%) N/A Flare Traversable LT? N/A N/A Flare Traversable RT? N/A Landing Length (in) N/A N/A DWS Provided? N/A N/A **DWS Contrast?** N/A Landing Width (in) N/A Landing Slope (%) N/A N/A DWS Length (in) N/A Landing X Slope (%) N/A N/A DWS Full Width? N/A Landing Curb? (Y/N) N/A N/A DWS Offset (in) N/A Shared Landing? N/A N/A **Gutter Ponding?** N/A N/A Gutter Slope (%) N/A N/A N/A Gutter Lip Ht (in) Gutter X Slope (%) N/A N/A Painted X Walk1? Yes Painted X Walk2? To W X Walk 1 Direction X Walk 2 Direction To S X Walk 1 Width (in) 112.0 X Walk 2 Width (in) 2.5 X Walk 2 Slope (%) X Walk 1 Slope (%) X Walk 1 X Slope (%) 4.1 X Walk 2 X Slope (%) N/A Ramp inside XWalk1? Yes N/A Ramp inside XWalk2? 2.9 Road Slope (%) Clear Space? Road X Slope (%) 3.9 N/A Clear Space to XWalk (in) N/A Any Obstruction? **Obstruction Type**

Street 1 Name Signal Stop Condition-Street 1 SCALEYBARK RD Street 2 Name Signal Stop Condition-Street 2 E WOODLAWN RD Possible Solutions: Remove & Replace Curb Ramp With Two New Directional Ramps or Equivalent. Surveyor Notes: N/A PROW/ADA: Not Found, R304.3.2
