# Access Compliance Report

## Public Rights-of-Way

### (Curb Ramps)

Intersection ID: 15195	Main Street: ALBEMARLE_RD	Cross Street: FARM_POND_LN	Location: SW
ADA ID: 8BCB9008C993	Ramp Type: Perp	Initial Pass/Fail: Fail	Overall Compliance: No
Severity Score: 8.75			
Codes/Mitigation Info/Possible Solution		Field Measurements/Component Compliance

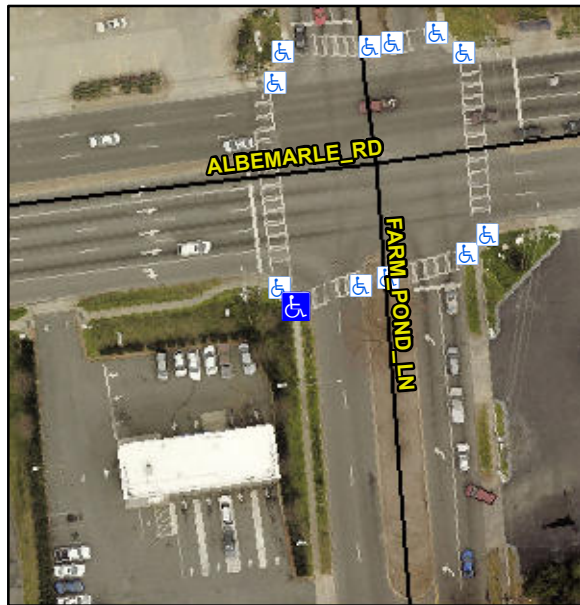
**Not Found, R304.5.1**

Compliance	Description	Data	Compliance	Description	Data
N/A	Ramp Length (in)	79.5	Yes	Ramp Slope (%)	7.3
No	Ramp Width (in)	38.0	Yes	Ramp XSlope (%)	1.8
N/A	Flare Type LT	N/A	N/A	Flare Type RT	N/A
N/A	Flare Slope LT (%)	N/A	N/A	Flare Slope RT (%)	N/A
N/A	Flare Traversable LT?	N/A	N/A	Flare Traversable RT?	N/A
N/A	Landing Length (in)	N/A	N/A	DWS Provided?	N/A
N/A	Landing Width (in)	N/A	N/A	DWS Contrast?	N/A
N/A	Landing Slope (%)	N/A	N/A	DWS Length (in)	N/A
N/A	Landing X Slope (%)	N/A	N/A	DWS Full Width?	N/A
N/A	Landing Curb? (Y/N)	N/A	N/A	DWS Offset (in)	N/A
N/A	Shared Landing?	N/A			
N/A	Gutter Ponding?	N/A	N/A	Gutter Slope (%)	N/A
N/A	Gutter Lip Ht (in)	N/A	N/A	Gutter X Slope (%)	N/A
N/A	Painted X Walk1?	Yes	N/A	Painted X Walk2?	N/A
	X Walk 1 Direction	To E		X Walk 2 Direction	N/A
N/A	X Walk 1 Width (in)	109.5	N/A	X Walk 2 Width (in)	N/A
	X Walk 1 Slope (%)	5.8		X Walk 2 Slope (%)	N/A
	X Walk 1 X Slope (%)	1.9		X Walk 2 X Slope (%)	N/A

N/A	Ramp inside XWalk1?	Yes	N/A	Ramp inside XWalk2?	N/A
	Road Slope (%)	N/A	N/A	Clear Space?	N/A
	Road X Slope (%)	N/A	N/A	Clear Space to XWalk (in)	N/A
N/A	Any Obstructions?	N/A	N/A	Storm Grate/Utility Hazard?	N/A
	Obstruction Type			Storm Grate/Utility Type	
		N/A			N/A
		Yes		Surface Condition? (G/P)	Good

**Remove & Replace Entire Ramp.**

Total Cost: \$ 1850.00
