Access Compliance Report

Public Rights-of-Way

(Curb Ramps)

Intersection ID: 9126	Main Street: REDBUD_ST	Cross Street: PITTS_DR	Location: NW
ADA ID: 8BCC3435C90E	Ramp Type: Para	Initial Pass/Fail: Fail	Overall Compliance: No
Severity Score: 22.5			
Codes/Mitigation Info/Possible Solution		Field Measurements/Component Compliance

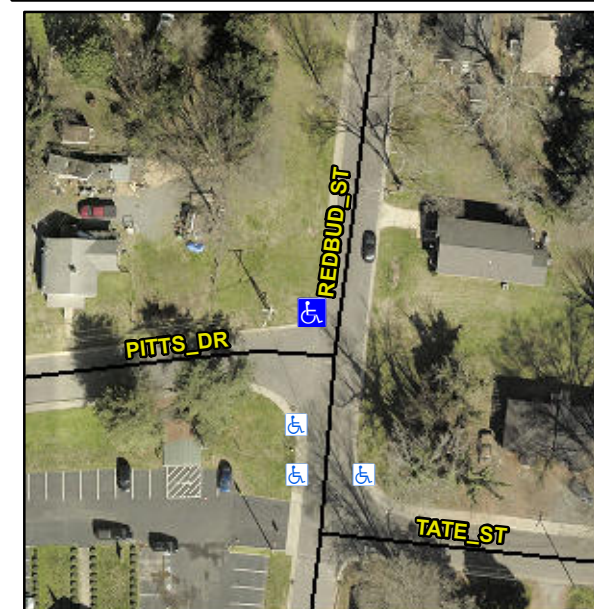
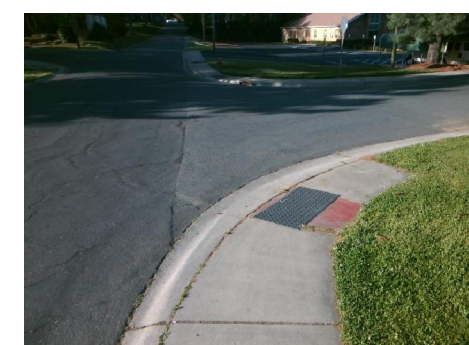
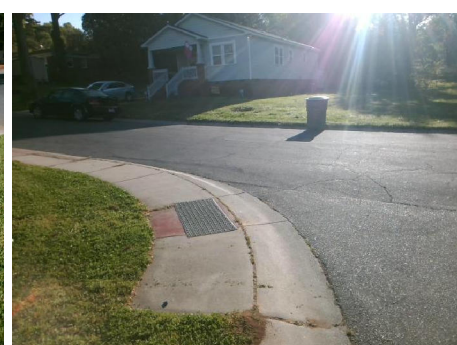
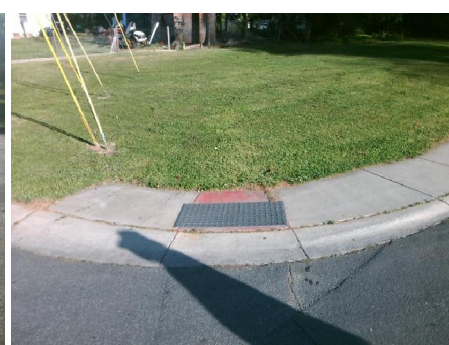
LT RP < 5%

Compliance	Description	Data	Compliance	Description	Data
N/A	Ramp Length LT (in)	58.0	N/A	Ramp Length RT (in)	57.0
No	Ramp Width LT (in)	46.0	Yes	Ramp Width RT (in)	56.0
Yes	Ramp Slope LT (%)	2.4	No	Ramp Slope RT (%)	10.6
Yes	Ramp XSlope LT (%)	1.9	No	Ramp XSlope RT (%)	2.9
N/A	Landing Length (in)	N/A	N/A	DWS Provided?	N/A
N/A	Landing Width (in)	N/A	N/A	DWS Contrast?	N/A
N/A	Landing Slope (%)	N/A	N/A	DWS Length (in)	N/A
N/A	Landing X Slope (%)	N/A	N/A	DWS Full Width?	N/A
N/A	Landing Curb? (Y/N)	N/A	N/A	DWS Offset (in)	N/A
N/A	Shared Landing?	N/A			
N/A	Gutter Ponding?	N/A	N/A	Gutter Slope (%)	N/A
N/A	Gutter Lip Ht (in)	N/A	N/A	Gutter X Slope (%)	N/A
N/A	Painted X Walk1?	No	N/A	Painted X Walk2?	N/A
	X Walk 1 Direction	To S		X Walk 2 Direction	N/A
N/A	X Walk 1 Width (in)	N/A	N/A	X Walk 2 Width (in)	N/A
	X Walk 1 Slope (%)	3.6		X Walk 2 Slope (%)	N/A
	X Walk 1 X Slope (%)	0.7		X Walk 2 X Slope (%)	N/A
N/A	Ramp inside XWalk1?	N/A	N/A	Ramp inside XWalk2?	N/A

Road Slope (%)	N/A	N/A	Clear Space?	N/A
	Road X Slope (%)	N/A	N/A	Clear Space to XWalk (in)	N/A
N/A	Any Obstructions?	N/A	N/A	Storm Grate/Utility Hazard?	N/A
	Obstruction Type			Storm Grate/Utility Type	
		N/A			N/A
			Yes	Surface Condition? (G/P)	Good
			N/A	Curb Slope (%)	7.8

Possible Solutions:

Remove & Replace Entire Ramp.
