# Access Compliance Report

## Public Rights-of-Way

| Intersection ID: 47965 | Main Street: TURNING_HAWK_RD | Cross Street: MESA_VERDE_RD | Location: NE |
| ADA ID: 8BD3EB03609C | Ramp Type: PerpDiag | Initial Pass/Fail: Fail | Overall Compliance: No |

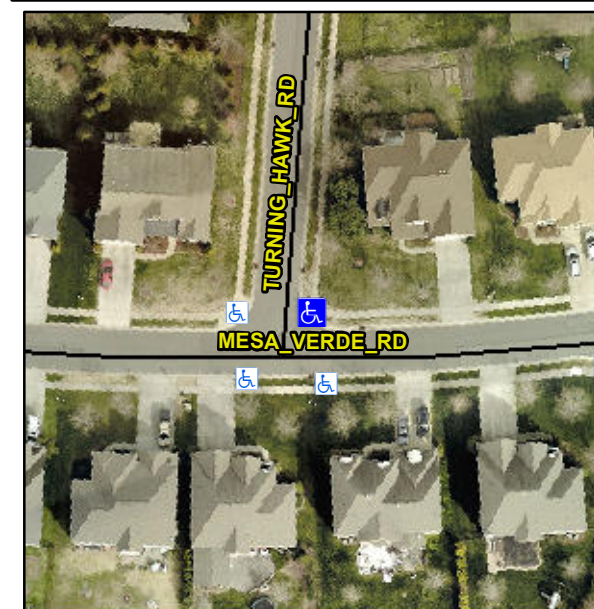
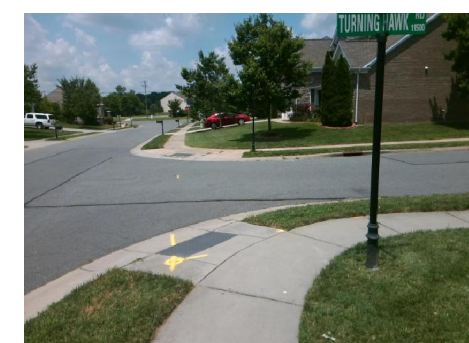
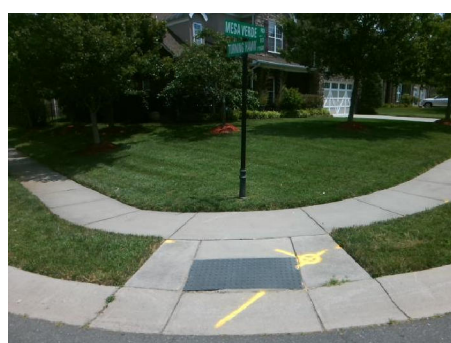
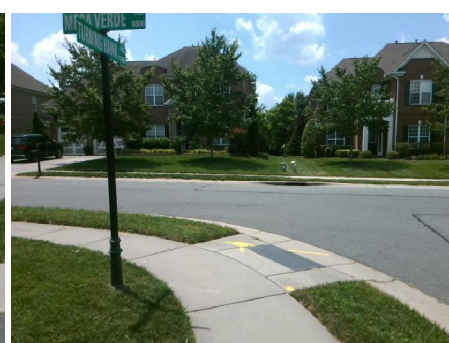
**Not Found, R304.5.1, R304.2.2, R304.5.3**

| Compliance | Description | Data | Compliance | Description | Data |
|---|---|---|---|---|---|
| N/A | Ramp Length (in) | 45.0 | No | Ramp Slope (%) | 10.4 |
| No | Ramp Width (in) | 46.0 | No | Ramp XSlope (%) | 5.4 |

**Remove & Replace Curb Ramp With Two New Directional Ramps or Equivalent.**
