# Access Compliance Report

## Public Rights-of-Way

### (Curb Ramps)

Intersection ID: 28369	Main Street: TONAWANDA_DR	Cross Street: BURNSIDE_LN	Location:	N
ADA ID: 8BE180CB7D25	Ramp Type: Perp	Initial Pass/Fail: Fail	Overall Compliance: No	Severity Score: 12.5

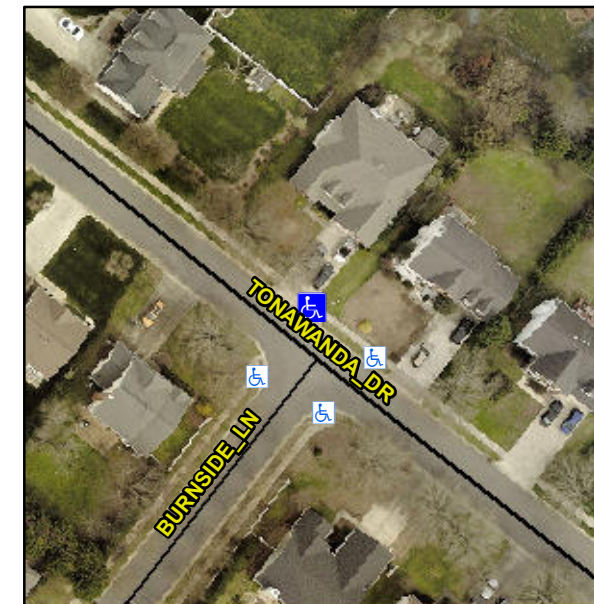
Surveyor Notes:

**N/A**

PROW/ADA:

**Not Found, R304.2.2**

Compliance	Description	Data	Compliance	Description	Data
N/A	Ramp Length (in)	47.0	No	Ramp Slope (%)	8.7
Yes	Ramp Width (in)	48.0	Yes	Ramp XSlope (%)	0.1
N/A	Flare Type LT	N/A	N/A	Flare Type RT	N/A
N/A	Flare Slope LT (%)	N/A	N/A	Flare Slope RT (%)	N/A
N/A	Flare Traversable LT?	N/A	N/A	Flare Traversable RT?	N/A
N/A	Landing Length (in)	N/A	N/A	DWS Provided?	N/A
N/A	Landing Width (in)	N/A	N/A	DWS Contrast?	N/A
N/A	Landing Slope (%)	N/A	N/A	DWS Length (in)	N/A
N/A	Landing X Slope (%)	N/A	N/A	DWS Full Width?	N/A
N/A	Landing Curb? (Y/N)	N/A	N/A	DWS Offset (in)	N/A
N/A	Shared Landing?	N/A			
N/A	Gutter Ponding?	N/A	N/A	Gutter Slope (%)	N/A
N/A	Gutter Lip Ht (in)	N/A	N/A	Gutter X Slope (%)	N/A
N/A	Painted X Walk1?	No	N/A	Painted X Walk2?	N/A
	X Walk 1 Direction	To SW		X Walk 2 Direction	N/A
N/A	X Walk 1 Width (in)	N/A	N/A	X Walk 2 Width (in)	N/A
	X Walk 1 Slope (%)	3.0		X Walk 2 Slope (%)	N/A
	X Walk 1 X Slope (%)	1.6		X Walk 2 X Slope (%)	N/A

N/A	Ramp inside XWalk1?	N/A	N/A	Ramp inside XWalk2?	N/A
	Road Slope (%)	N/A	N/A	Clear Space?	N/A
	Road X Slope (%)	N/A	N/A	Clear Space to XWalk (in)	N/A
N/A	Any Obstructions?	N/A	N/A	Storm Grate/Utility Hazard?	N/A
	Obstruction Type			Storm Grate/Utility Type	
		N/A			N/A
			Yes	Surface Condition? (G/P)	Good

Possible Solutions:

**Remove & Replace Entire Ramp.**

Total Cost: \$ 1850.00
