Access Compliance Report Public Rights-of-Way (Curb Ramps)

Intersection ID: 22573	Main Street: INDIAN_HILLS_LN	Cross Street: SEASCAPE_LN	Location: SE
ADA ID: 8BF8D3CE6FF4	Ramp Type: Directional1	Initial Pass/Fail: Fail	Overall Compliance: No Severity Score: 8.75

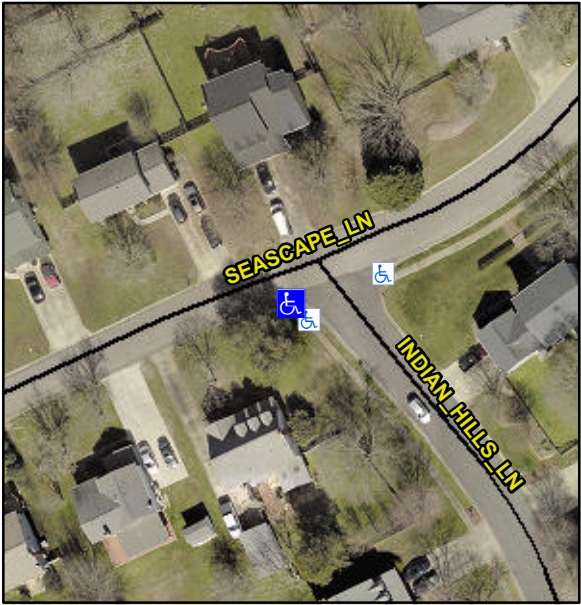
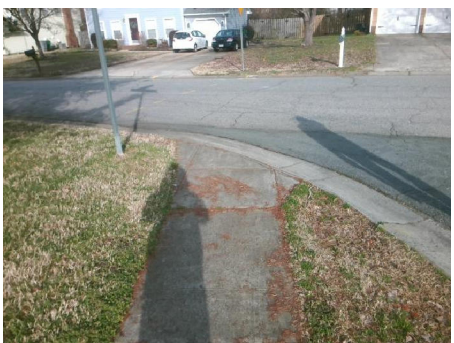
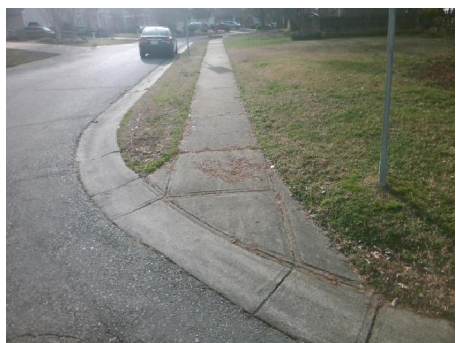
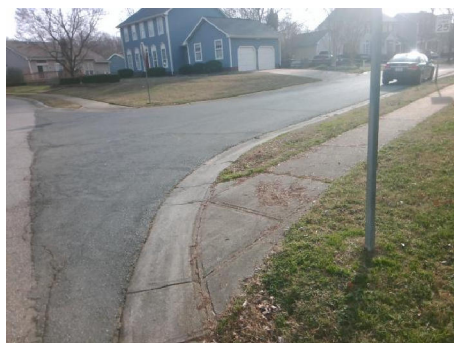
Compliance	Description	Data	Compliance	Description	Data
N/A	Ramp Length (in)	48.5	N/A	Grade Break?	N/A
No	Ramp Width (in)	47.0	N/A	Grade Break Slope (%)	0.0
Yes	Ramp Slope (%)	5.4	N/A	Grade Break XSlope (%)	0.0
Yes	Ramp XSlope (%)	0.1			
N/A	Flare Type LT	N/A	N/A	Flare Type RT	N/A
N/A	Flare Slope LT (%)	N/A	N/A	Flare Slope RT (%)	0.0
N/A	Flare Traversable LT?	N/A	N/A	Flare Traversable RT?	N/A
N/A	Landing Length (in)	0.0	N/A	DWS Provided?	N/A
N/A	Landing Width (in)	0.0	N/A	DWS Contrast?	N/A
N/A	Landing Slope (%)	0.0	N/A	DWS Length (in)	N/A
N/A	Landing X Slope (%)	0.0	N/A	DWS Full Width?	N/A
N/A	Landing Curb? (Y/N)	N/A	N/A	DWS Offset LT (in)	N/A
N/A	Shared Landing?	N/A	N/A	DWS Offset RT (in)	N/A
N/A	Gutter Ponding?	0.0	N/A	Gutter Slope (%)	N/A
N/A	Gutter Lip Ht (in)	0.0	N/A	Gutter X Slope (%)	N/A
N/A	Painted X Walk1?	No		Road Slope (%)	3.7
	X Walk 1 Direction	To NE		Road X Slope (%)	2.7
	X Walk 1 Width (in)	N/A		Clear Space?	N/A

X Walk 1 Slope (%)	3.7	N/A	Clear Space to XWalk (in)	N/A
	X Walk 1 X Slope (%)	2.7	N/A	Storm Grate/Utility Hazard?	N/A
N/A	Ramp inside XWalk1?	N/A		Storm Grate/Utility Type	
N/A	Any Obstructions?	N/A			N/A
	Obstruction Type		Yes	Surface Condition? (G/P)	Good
			N/A	Curb Slope (%)	4.1

Possible Solutions:
Remove & Replace Entire Ramp.
