# Access Compliance Report

## Public Rights-of-Way

### (Curb Ramps)

| Intersection ID: 50603 | Main Street: RHODORA_RD | Cross Street: EMPRESS_CT | Location: SW |

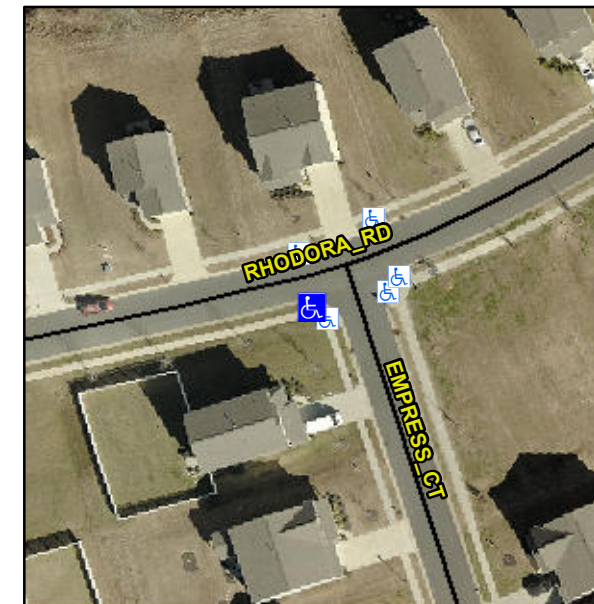
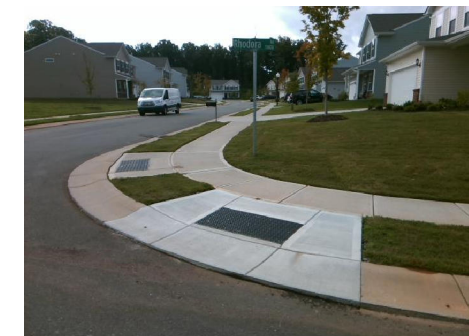
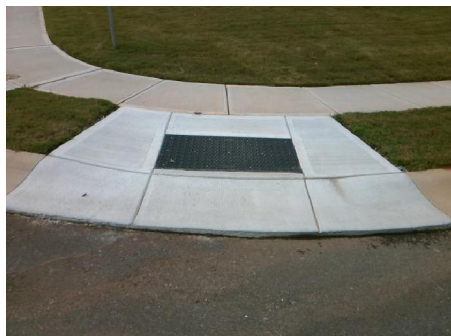
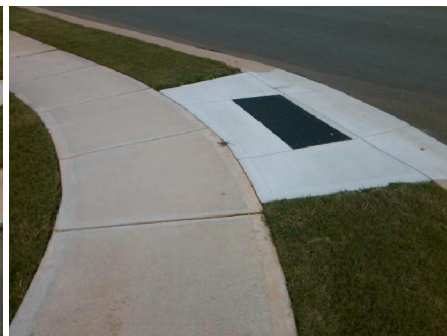
| ADA ID: 8C03001CD899 | Ramp Type: Perp | Initial Pass/Fail: Fail | Overall Compliance: No |
| Severity Score: 22.5 | | | |

**Not Found, R304.5.1, R304.2.2**

| Compliance | Description | Data | Compliance | Description | Data |
|---|---|---|---|---|---|
| N/A | Ramp Length (in) | 49.5 | No | Ramp Slope (%) | 9.4 |
| No | Ramp Width (in) | 47.5 | Yes | Ramp XSlope (%) | 2.8 |

**Remove & Replace Entire Ramp.**

Total Cost: \$ 1850.00
