# Access Compliance Report

## Public Rights-of-Way

### (Curb Ramps)

Intersection ID: 48563	Main Street: MASON_MILL_PL	Cross Street: HAINES_MILL_RD	Location: NW
ADA ID: 8C14A0469759	Ramp Type: BlendTrans1	Initial Pass/Fail: Fail	Overall Compliance: No
Severity Score: 12.5			
Codes/Mitigation Info/Possible Solution		Field Measurements/Component Compliance

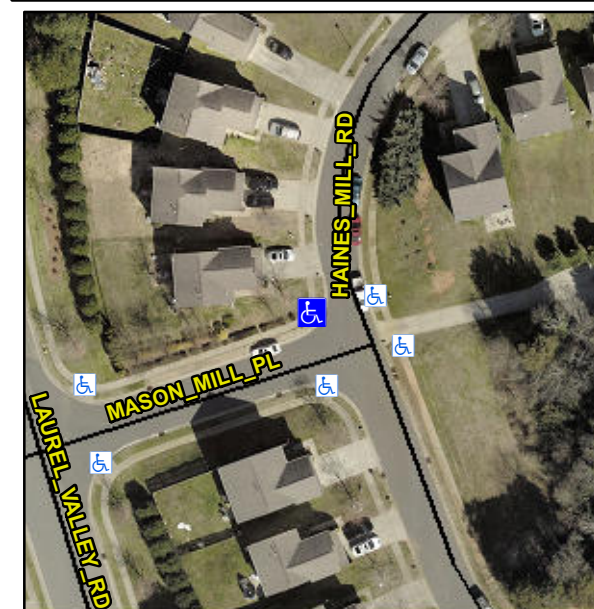
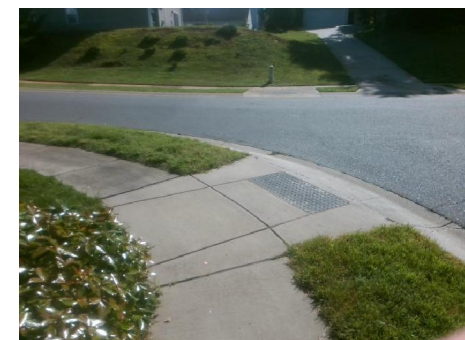
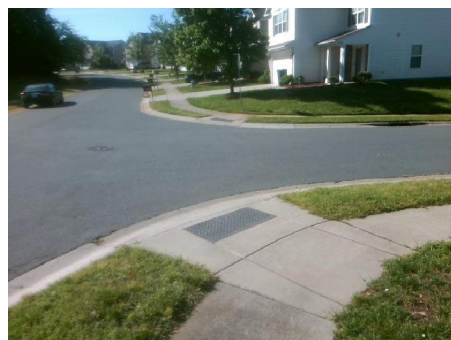
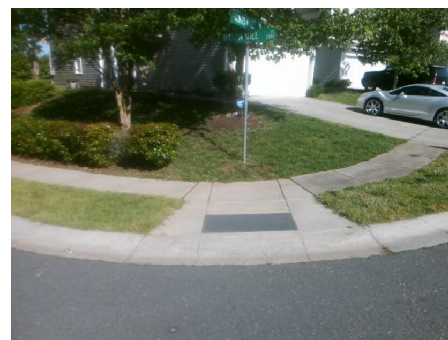
**Not Found, R304.5.3**

Compliance	Description	Data	Compliance	Description	Data
N/A	Ramp Length (in)	48.0	Yes	BlendTrans Slope (%)	1.5
Yes	Ramp Width (in)	48.0	No	BlendTrans XSlope (%)	6.4
N/A	Flare Type LT	N/A	N/A	Flare Type RT	N/A
N/A	Flare Slope LT (%)	N/A	N/A	Flare Slope RT (%)	N/A
N/A	Flare Traversable LT?	N/A	N/A	Flare Traversable RT?	N/A
N/A	Landing Length (in)	N/A	N/A	DWS Provided?	N/A
N/A	Landing Width (in)	N/A	N/A	DWS Contrast?	N/A
N/A	Landing Slope (%)	N/A	N/A	DWS Length (in)	N/A
N/A	Landing X Slope (%)	N/A	N/A	DWS Full Width?	N/A
N/A	Landing Curb? (Y/N)	N/A	N/A	DWS Offset (in)	N/A
N/A	Shared Landing?	N/A			
N/A	Gutter Ponding?	N/A	N/A	Gutter Slope (%)	N/A
N/A	Gutter Lip Ht (in)	N/A	N/A	Gutter X Slope (%)	N/A
N/A	Painted X Walk1?	No	N/A	Painted X Walk2?	No
	X Walk 1 Direction	To S		X Walk 2 Direction	To E
	X Walk 1 Width (in)	N/A		X Walk 2 Width (in)	N/A
	X Walk 1 Slope (%)	2.1		X Walk 2 Slope (%)	5.0
	X Walk 1 X Slope (%)	4.5		X Walk 2 X Slope (%)	0.3

N/A	Ramp inside XWalk1?	N/A	N/A	Ramp inside XWalk2?	N/A
	Road Slope (%)	5.2		Clear Space?	N/A
	Road X Slope (%)	3.3	N/A	Clear Space to XWalk (in)	N/A
N/A	Any Obstructions?	N/A	N/A	Storm Grate/Utility Hazard?	N/A
	Obstruction Type			Storm Grate/Utility Type	
		N/A			N/A
			Yes	Surface Condition? (G/P)	Good
			No	Curb Slope (%)	11.1

**Remove & Replace Curb Ramp With Two New Directional Ramps or Equivalent.**
