Access Compliance Report

Public Rights-of-Way

(Curb Ramps)

Intersection ID: 3761	Main Street: KEENELAND_LN	Cross Street: CLAIBORNE_WOODS_RD	Location: NE
ADA ID: 8C204468AEC3	Ramp Type: Perp	Initial Pass/Fail: Fail	Overall Compliance: No
Severity Score: 21.25			
Codes/Mitigation Info/Possible Solution		Field Measurements/Component Compliance

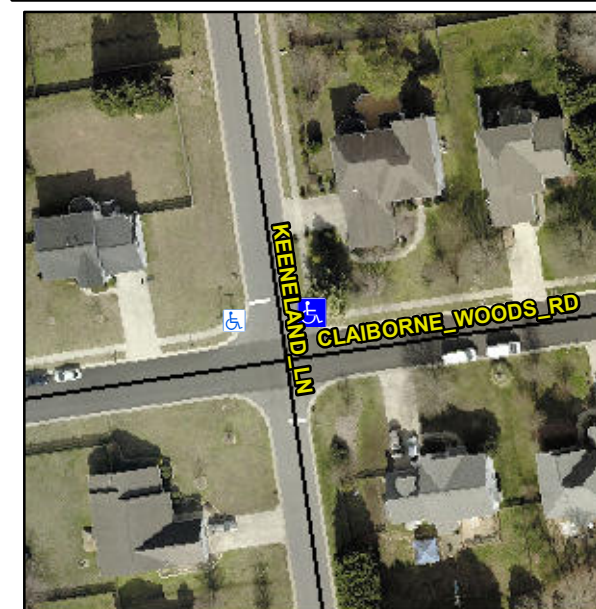
Not Found, R304.5.1, R304.5.3

Compliance	Description	Data	Compliance	Description	Data
N/A	Ramp Length (in)	46.0	Yes	Ramp Slope (%)	5.9
No	Ramp Width (in)	42.5	No	Ramp XSlope (%)	5.4
N/A	Flare Type LT	N/A	N/A	Flare Type RT	N/A
N/A	Flare Slope LT (%)	N/A	N/A	Flare Slope RT (%)	N/A
N/A	Flare Traversable LT?	N/A	N/A	Flare Traversable RT?	N/A
N/A	Landing Length (in)	N/A	N/A	DWS Provided?	N/A
N/A	Landing Width (in)	N/A	N/A	DWS Contrast?	N/A
N/A	Landing Slope (%)	N/A	N/A	DWS Length (in)	N/A
N/A	Landing X Slope (%)	N/A	N/A	DWS Full Width?	N/A
N/A	Landing Curb? (Y/N)	N/A	N/A	DWS Offset (in)	N/A
N/A	Shared Landing?	N/A			
N/A	Gutter Ponding?	N/A	N/A	Gutter Slope (%)	N/A
N/A	Gutter Lip Ht (in)	N/A	N/A	Gutter X Slope (%)	N/A
N/A	Painted X Walk1?	No	N/A	Painted X Walk2?	N/A
	X Walk 1 Direction	To W		X Walk 2 Direction	N/A
N/A	X Walk 1 Width (in)	N/A	N/A	X Walk 2 Width (in)	N/A
	X Walk 1 Slope (%)	7.8		X Walk 2 Slope (%)	N/A
	X Walk 1 X Slope (%)	1.6		X Walk 2 X Slope (%)	N/A

N/A	Ramp inside XWalk1?	N/A	N/A	Ramp inside XWalk2?	N/A
	Road Slope (%)	N/A	N/A	Clear Space?	N/A
	Road X Slope (%)	N/A	N/A	Clear Space to XWalk (in)	N/A
N/A	Any Obstructions?	N/A	N/A	Storm Grate/Utility Hazard?	N/A
	Obstruction Type			Storm Grate/Utility Type	
		N/A			N/A
			Yes	Surface Condition? (G/P)	Good

Possible Solutions:

Remove & Replace Entire Ramp.
