Access Compliance Report

Public Rights-of-Way

(Curb Ramps)

| Intersection ID: 14144 | Main Street: BRIAR_CREEK_RD | Cross Street: GREEN_OAKS_LN | Location: | N |

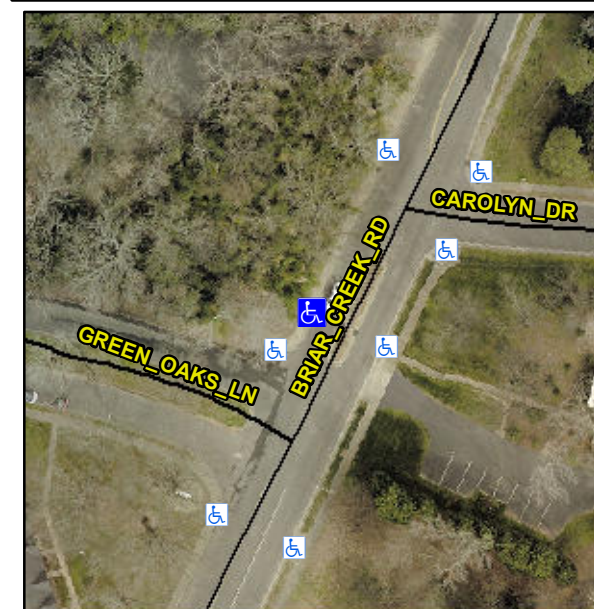
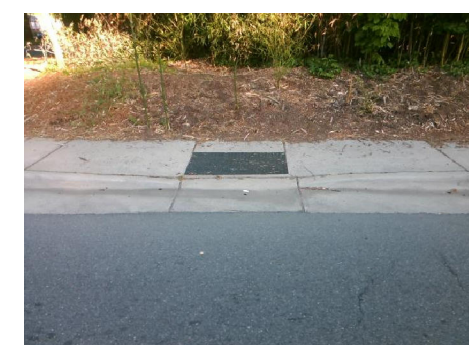
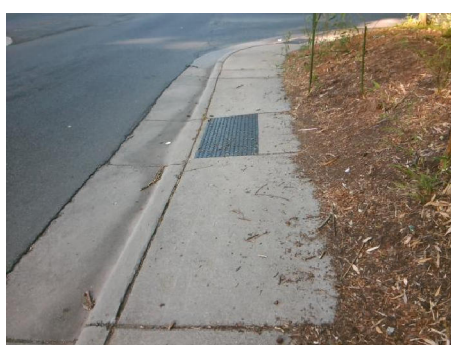
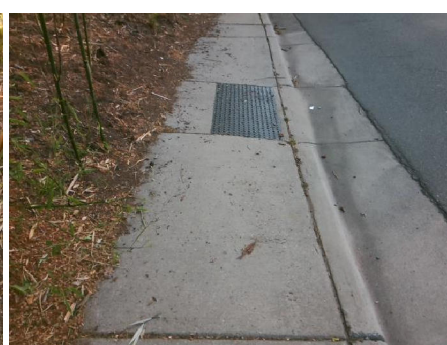
| ADA ID: 8C28F04DCDA7 | Ramp Type: Perp | Initial Pass/Fail: Fail | Overall Compliance: No | Severity Score: 37.5 |

Not Found, R304.2.2, R304.5.3

| Compliance | Description | Data | Compliance | Description | Data |
|---|---|---|---|---|---|
| N/A | Ramp Length (in) | 50.0 | No | Ramp Slope (%) | 12.4 |
| Yes | Ramp Width (in) | 48.0 | No | Ramp XSlope (%) | 5.1 |

Remove & Replace Entire Ramp.
