Access Compliance Report

Public Rights-of-Way

(Curb Ramps)

Intersection ID: 23437	Main Street: TRYON_ST	Cross Street: MOSS_RD	Location: NW
ADA ID: 8C2BDC5CB1B6	Ramp Type: MedianPerp	Initial Pass/Fail: Fail	Overall Compliance: No
Severity Score: 8.75			
Codes/Mitigation Info/Possible Solution		Field Measurements/Component Compliance

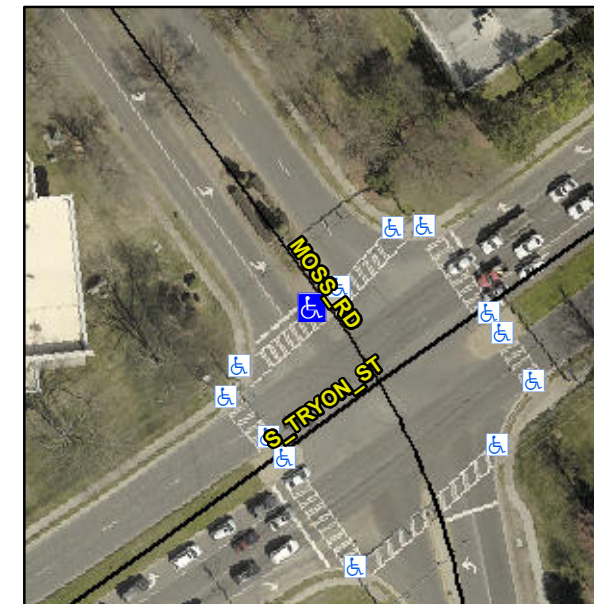
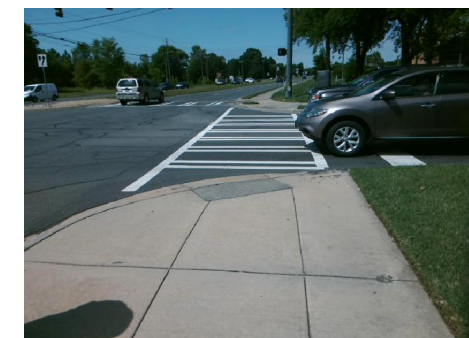
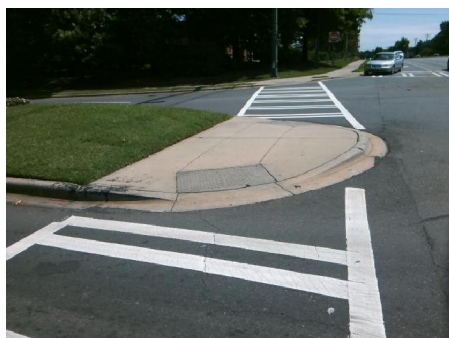
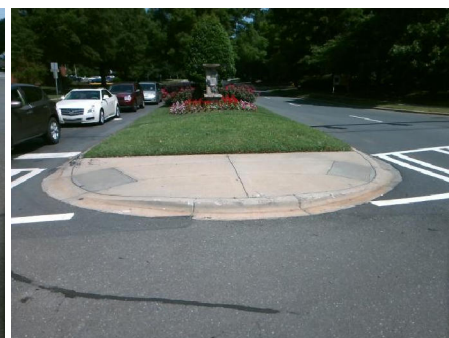
Not Found, R304.5.1

Compliance	Description	Data	Compliance	Description	Data
N/A	Ramp Length (in)	46.0	Yes	Ramp Slope (%)	6.6
No	Ramp Width (in)	41.5	Yes	Ramp XSlope (%)	0.8
N/A	Flare Type LT	N/A	N/A	Flare Type RT	N/A
N/A	Flare Slope LT (%)	N/A	N/A	Flare Slope RT (%)	N/A
N/A	Flare Traversable LT?	N/A	N/A	Flare Traversable RT?	N/A
N/A	Landing Length (in)	N/A	N/A	DWS Provided?	N/A
N/A	Landing Width (in)	N/A	N/A	DWS Contrast?	N/A
N/A	Landing Slope (%)	N/A	N/A	DWS Length (in)	N/A
N/A	Landing X Slope (%)	N/A	N/A	DWS Full Width?	N/A
N/A	Landing Curb? (Y/N)	N/A	N/A	DWS Offset (in)	N/A
N/A	Shared Landing?	N/A			
N/A	Gutter Ponding?	N/A	N/A	Gutter Slope (%)	N/A
N/A	Gutter Lip Ht (in)	N/A	N/A	Gutter X Slope (%)	N/A
N/A	Painted X Walk1?	Yes	N/A	Painted X Walk2?	N/A
	X Walk 1 Direction	To SW		X Walk 2 Direction	N/A
N/A	X Walk 1 Width (in)	111.0	N/A	X Walk 2 Width (in)	N/A
	X Walk 1 Slope (%)	0.7		X Walk 2 Slope (%)	N/A
	X Walk 1 X Slope (%)	1.9		X Walk 2 X Slope (%)	N/A

N/A	Ramp inside XWalk1?	Yes	N/A	Ramp inside XWalk2?	N/A
	Road Slope (%)	N/A	N/A	Clear Space?	N/A
	Road X Slope (%)	N/A	N/A	Clear Space to XWalk (in)	N/A
N/A	Any Obstructions?	N/A	N/A	Storm Grate/Utility Hazard?	N/A
	Obstruction Type			Storm Grate/Utility Type	
		N/A			N/A
		Yes		Surface Condition? (G/P)	Good

Remove & Replace Entire Ramp.
