# Access Compliance Report

## Public Rights-of-Way

| Intersection ID: 31683 | Main Street: GALLISON_AV | Cross Street: WILLIE_WORRELL_DR | Location: NE |
| ADA ID: 8C2D62CE2D94 | Ramp Type: PerpDiag | Initial Pass/Fail: Fail | Overall Compliance: No |

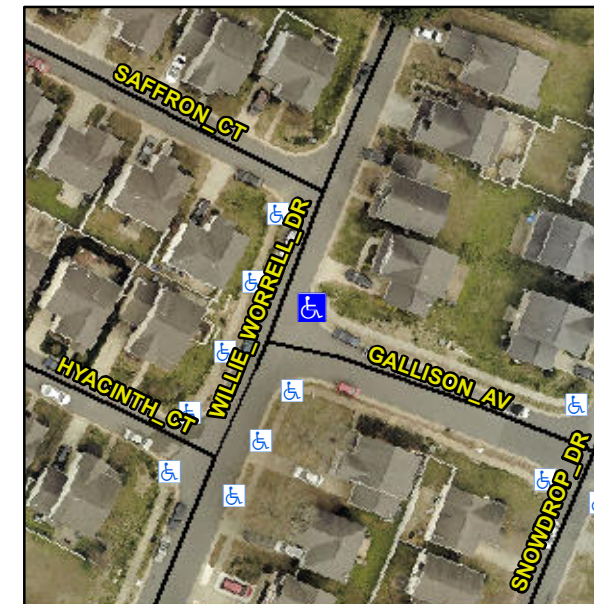
| Severity Score: 18.75 | | | |

**Not Found, R304.5.1, R304.5.3**

| Compliance | Description | Data | Compliance | Description | Data |
|---|---|---|---|---|---|
| N/A | Ramp Length (in) | 51.0 | Yes | Ramp Slope (%) | 5.2 |
| No | Ramp Width (in) | 35.0 | No | Ramp XSlope (%) | 4.8 |

**Remove & Replace Curb Ramp With Two New Directional Ramps or Equivalent.**

Total Cost: \$ 3200.00

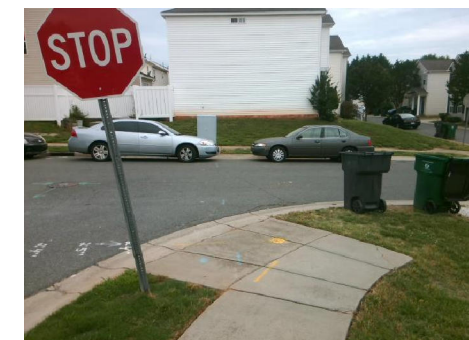
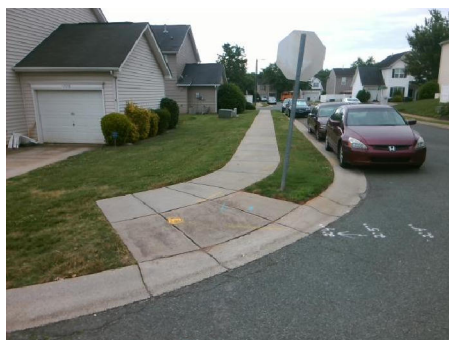
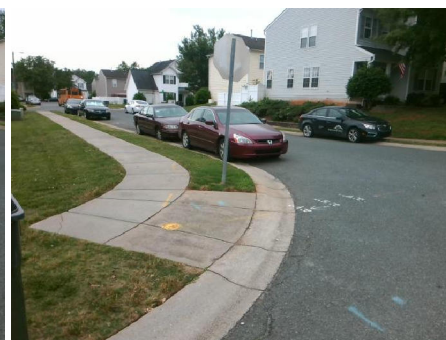
Street 1 Name **WILLIE WORRELL DR**  
 Stop Condition-Street 2 **None**  
 Street 2 Name **GALLISON AV**  
 Stop Condition-Street 1 **StopSign**
