Access Compliance Report

Public Rights-of-Way

(Curb Ramps)

| Intersection ID: 10019914 | Main Street: ARDREY_KELL_RD | Cross Street: N/A | Location: NW |

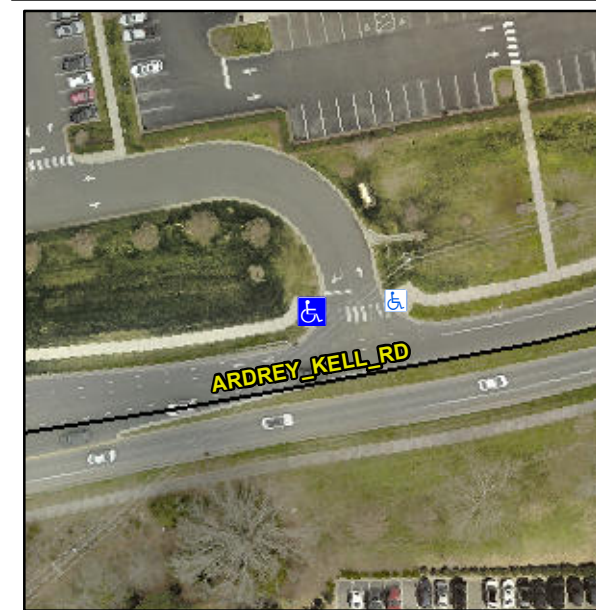
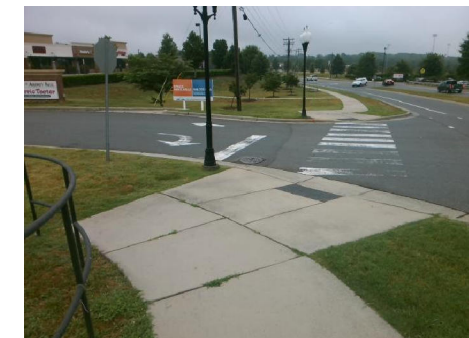
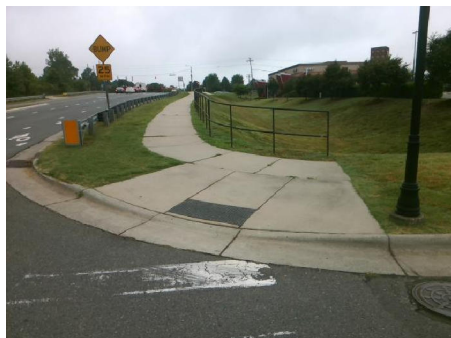
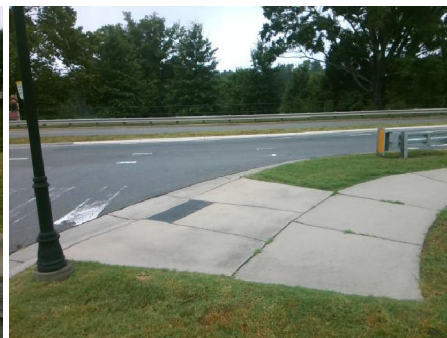
| ADA ID: 8C2EEA7BF543 | Ramp Type: Perp | Initial Pass/Fail: Fail | Overall Compliance: No |

Not Found, R304.5.3

| Compliance | Description | Data | Compliance | Description | Data |
|---|---|---|---|---|---|
| N/A | Ramp Length (in) | 98.0 | Yes | Ramp Slope (%) | 7.2 |
| Yes | Ramp Width (in) | 48.0 | No | Ramp XSlope (%) | 6.7 |

Remove & Replace Entire Ramp.

Total Cost: \$ 1850.00
