# Access Compliance Report

## Public Rights-of-Way

### (Curb Ramps)

Intersection ID: 53804	Main Street: NATHAN_DR	Cross Street: PITZER_DR	Location: W
ADA ID: 8C2FB2A5544A	Ramp Type: Perp	Initial Pass/Fail: Fail	Overall Compliance: No
Severity Score: 13.75			
Codes/Mitigation Info/Possible Solution		Field Measurements/Component Compliance

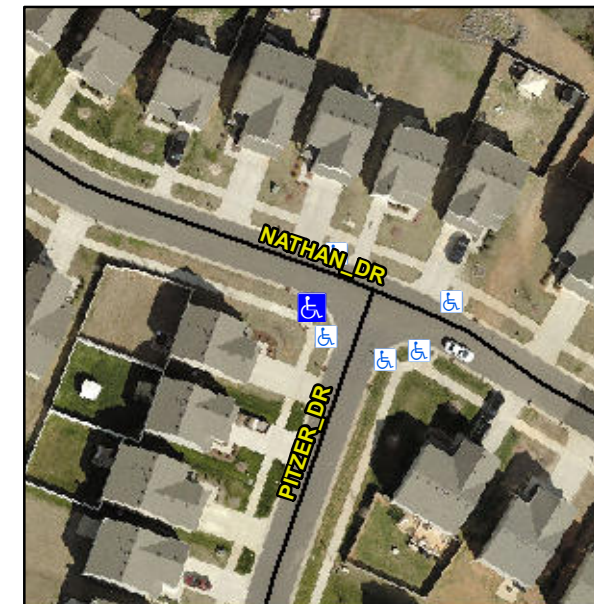
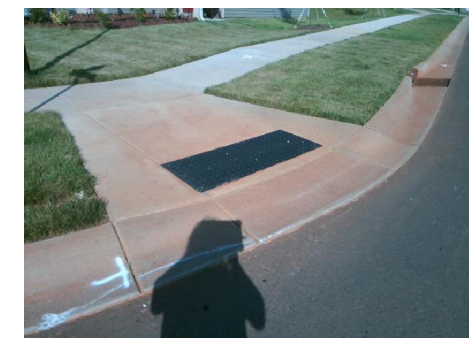
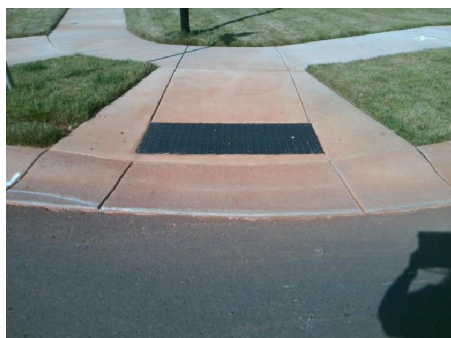
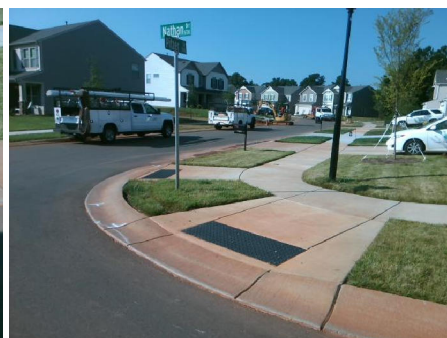
**R304.2.2, R304.5.3**

Compliance	Description	Data	Compliance	Description	Data
N/A	Ramp Length (in)	99.0	No	Ramp Slope (%)	10.6
Yes	Ramp Width (in)	61.0	No	Ramp XSlope (%)	2.7
N/A	Flare Type LT	N/A	N/A	Flare Type RT	N/A
N/A	Flare Slope LT (%)	N/A	N/A	Flare Slope RT (%)	N/A
N/A	Flare Traversable LT?	N/A	N/A	Flare Traversable RT?	N/A
N/A	Landing Length (in)	N/A	N/A	DWS Provided?	N/A
N/A	Landing Width (in)	N/A	N/A	DWS Contrast?	N/A
N/A	Landing Slope (%)	N/A	N/A	DWS Length (in)	N/A
N/A	Landing X Slope (%)	N/A	N/A	DWS Full Width?	N/A
N/A	Landing Curb? (Y/N)	N/A	N/A	DWS Offset (in)	N/A
N/A	Shared Landing?	N/A			
N/A	Gutter Ponding?	N/A	N/A	Gutter Slope (%)	N/A
N/A	Gutter Lip Ht (in)	N/A	N/A	Gutter X Slope (%)	N/A
N/A	Painted X Walk1?	No	N/A	Painted X Walk2?	N/A
	X Walk 1 Direction	To N		X Walk 2 Direction	N/A
N/A	X Walk 1 Width (in)	N/A	N/A	X Walk 2 Width (in)	N/A
	X Walk 1 Slope (%)	2.8		X Walk 2 Slope (%)	N/A
	X Walk 1 X Slope (%)	2.0		X Walk 2 X Slope (%)	N/A

N/A	Ramp inside XWalk1?	N/A	N/A	Ramp inside XWalk2?	N/A
	Road Slope (%)	N/A	N/A	Clear Space?	N/A
	Road X Slope (%)	N/A	N/A	Clear Space to XWalk (in)	N/A
N/A	Any Obstructions?	N/A	N/A	Storm Grate/Utility Hazard?	N/A
	Obstruction Type			Storm Grate/Utility Type	
		N/A			N/A
			Yes	Surface Condition? (G/P)	Good

**Remove & Replace Entire Ramp.**

**\$ 1850.00**
