# Access Compliance Report

## Public Rights-of-Way

### (Curb Ramps)

| Intersection ID: 30136 | Main Street: GALESBURG_ST | Cross Street: SIDELL_LN | Location: NW |

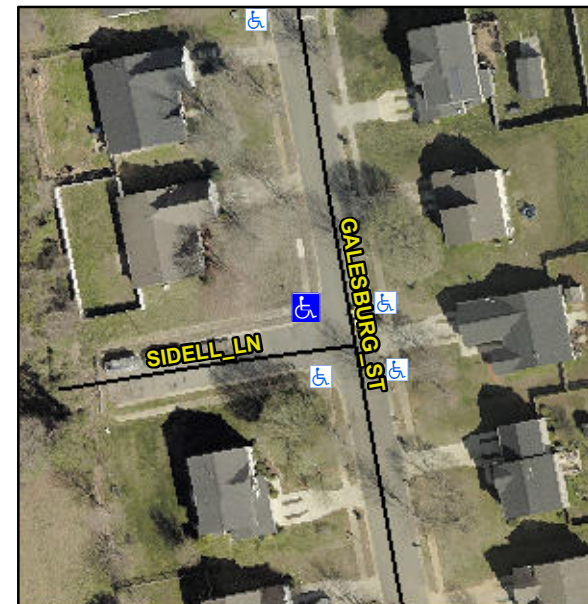
**R304.2.1, R304.2.2-Perp, R304.3.2-Para, R305.2**

| Compliance | Description | Data | Compliance | Description | Data |
|---|---|---|---|---|---|
| No | Landing Length (in) | 47.0 | Yes | DWS Provided? | Yes |
| No | Landing Slope (%) | 3.1 | Yes | DWS Length (in) | 25.0 |
| N/A | Landing Curb? (Y/N) | No | No | DWS Offset (in) | 4.0 |

**Remove & Replace Curb Ramp With Two New Directional Ramps or Equivalent.**
