# Access Compliance Report

## Public Rights-of-Way

Intersection ID: 11835	Main Street: BELMONT_AV	Cross Street: N_DAVIDSON_ST	Location: N
ADA ID: 8C34F37C482E	Ramp Type: PerpDiag	Initial Pass/Fail: Fail	Overall Compliance: No
Severity Score: 8.75			
Codes/Mitigation Info/Possible Solution		Field Measurements/Component Compliance

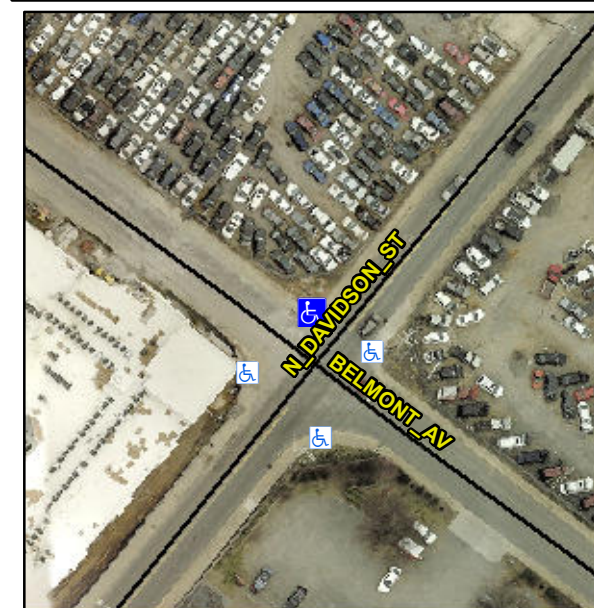
**Not Found, R304.5.1**

Compliance	Description	Data	Compliance	Description	Data
N/A	Ramp Length (in)	78.0	Yes	Ramp Slope (%)	7.0
No	Ramp Width (in)	40.0	Yes	Ramp XSlope (%)	0.6
N/A	Flare Type LT	N/A	N/A	Flare Type RT	N/A
N/A	Flare Slope LT (%)	N/A	N/A	Flare Slope RT (%)	N/A
N/A	Flare Traversable LT?	N/A	N/A	Flare Traversable RT?	N/A
N/A	Landing Length (in)	N/A	N/A	DWS Provided?	N/A
N/A	Landing Width (in)	N/A	N/A	DWS Contrast?	N/A
N/A	Landing Slope (%)	N/A	N/A	DWS Length (in)	N/A
N/A	Landing X Slope (%)	N/A	N/A	DWS Full Width?	N/A
N/A	Landing Curb? (Y/N)	N/A	N/A	DWS Offset (in)	N/A
N/A	Shared Landing?	N/A			
N/A	Gutter Ponding?	N/A	N/A	Gutter Slope (%)	N/A
N/A	Gutter Lip Ht (in)	N/A	N/A	Gutter X Slope (%)	N/A
N/A	Painted X Walk1?	No	N/A	Painted X Walk2?	No
	X Walk 1 Direction	To SW		X Walk 2 Direction	To SE
N/A	X Walk 1 Width (in)	N/A	N/A	X Walk 2 Width (in)	N/A
	X Walk 1 Slope (%)	4.5		X Walk 2 Slope (%)	4.9
	X Walk 1 X Slope (%)	2.0		X Walk 2 X Slope (%)	1.9

**Remove & Replace Curb Ramp With Two New Directional Ramps or Equivalent.**

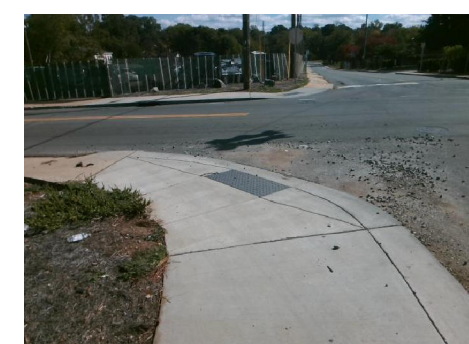
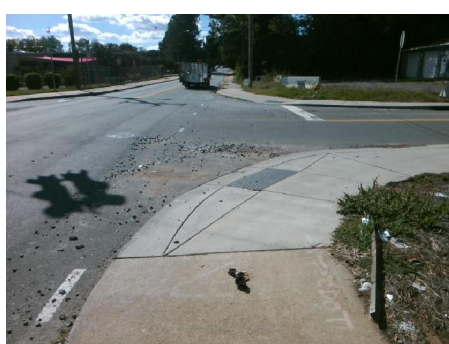
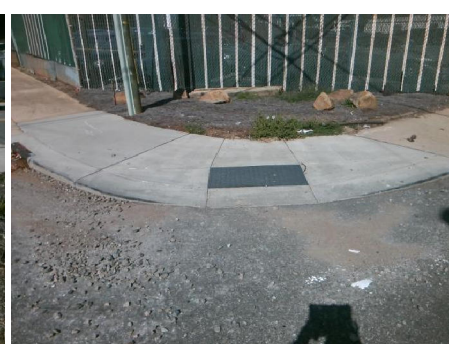
N/A	Ramp inside XWalk1?	N/A	N/A	Ramp inside XWalk2?	N/A
	Road Slope (%)	2.6	N/A	Clear Space?	N/A
	Road X Slope (%)	4.8	N/A	Clear Space to XWalk (in)	N/A
N/A	Any Obstructions?	N/A	N/A	Storm Grate/Utility Hazard?	N/A
	Obstruction Type			Storm Grate/Utility Type	
		N/A			N/A
		Yes		Surface Condition? (G/P)	Good
